JOB REF: XXXX

ROOF REPORT

Leicester
Leicestershire
LE3 XXX

We have been instructed by XXXX to prepare an independent report on the main roof of the church.

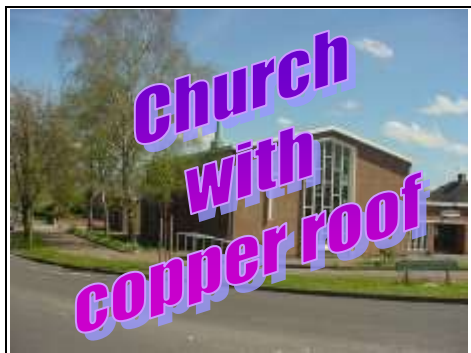
Left view left with trees

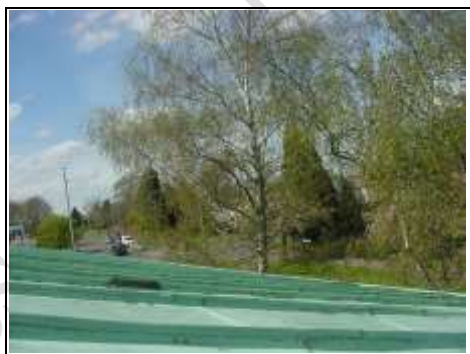
Left side roof looking forwards

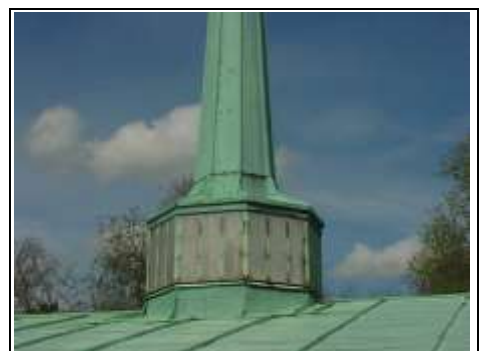
Looking at steeple right side main
roof

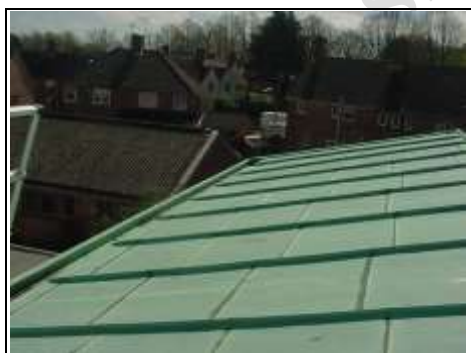
Ladder accessed front right side
main roof

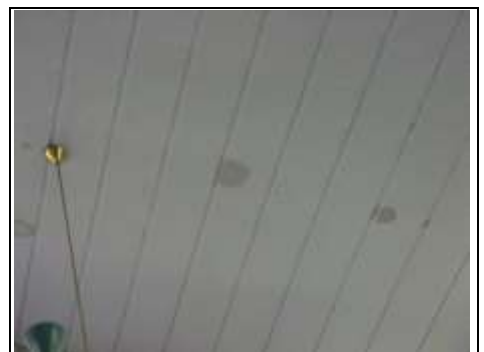
Close up of possible roof leaks or condensation, further investigation required

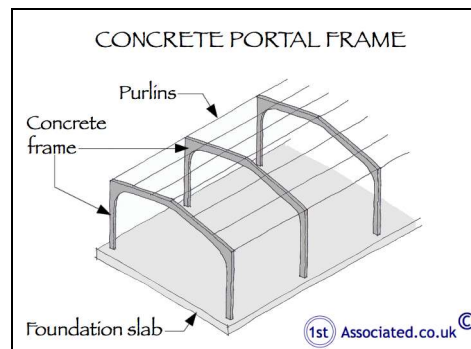
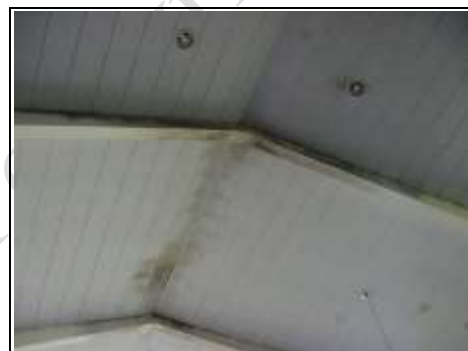
We believe that staining internally is partly due to cold bridging on the concrete portal frame.

Cold bridging is caused by a colder element in the structure allowing coldness to pass through the structure much quicker when warm moist air is present in the property.

Close up of cold bridging

We would recommend ventilation at high level to soffits to help reduce condensation in the main hall.

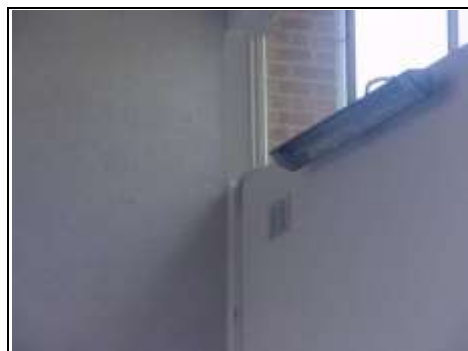
Air vent at rear
(high level electric heaters we were advised are not working)

We would also recommend re-instating the high level heating with a modern equivalent that should both help warm the property and reduce the cold bridging.

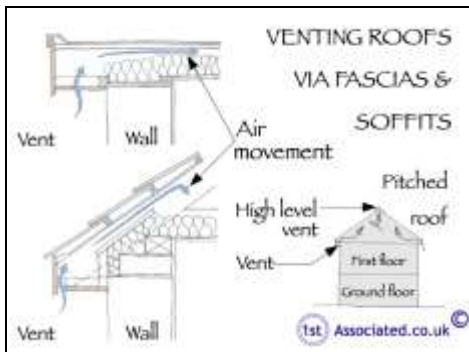
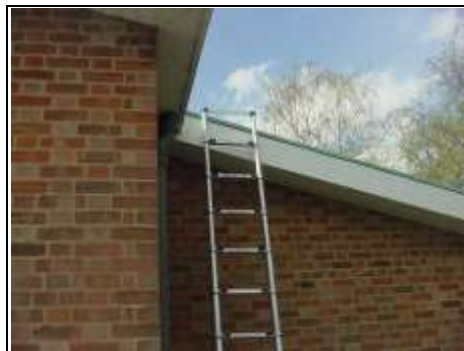
We recommend improving ventilation in the main hall by adding vents to the soffit boards. As we understand it the original timber fascias and soffits have been overclad with plastic.

Overclad soffit

When adding vents check the condition of the fascias and soffits as you may need to replace the fascias and soffits completely if the timber is rotten below.

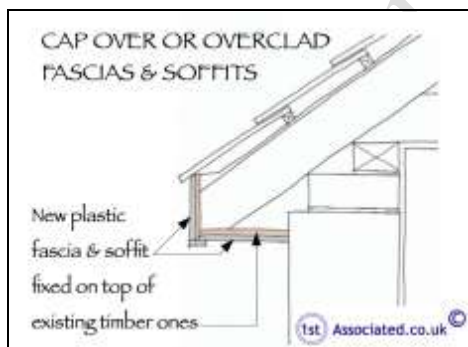
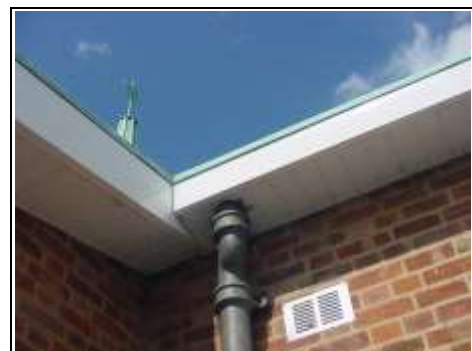
Fascias and soffits, add ventilation into fascias however we would never recommend overcladding existing fascias and soffits and ideally this should be replaced rather than what we believe to be stick on fascias and soffits

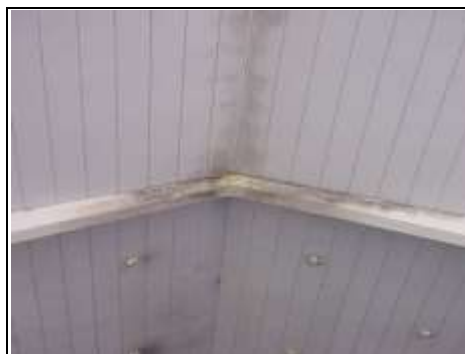
Black staining to portal frame, cold bridging

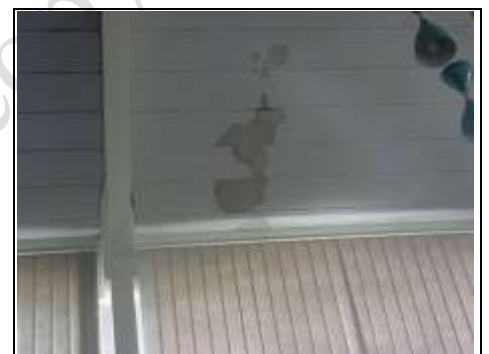
Patch/spot staining to ceiling

- 7.1) Staining to the concrete portal frame known as cold bridging
- 7.2) Patch/spot staining which we believe is from the roof.

We recommend that the interior of the church is redecorated and the ceiling is monitored for any further patch/spot staining to monitor for leakage from weak areas of the roof.

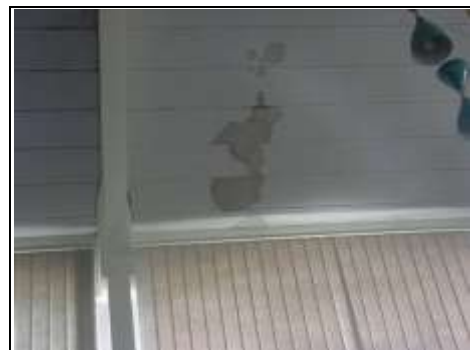
We believe the dampness that can be seen internally is a mixture of what is known as cold bridging and some roof leaks which are the spot/patch stains.

Patch/spot staining to ceiling

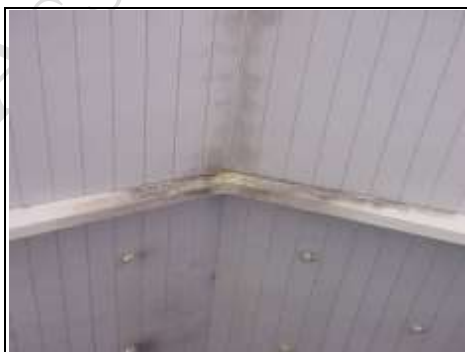
Cold bridging to portal frame and also to the ridge of the roof

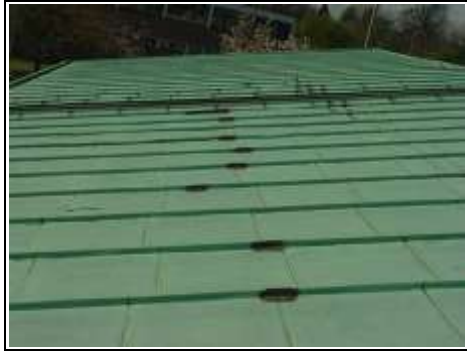
Repairs that have been carried out to the main roof

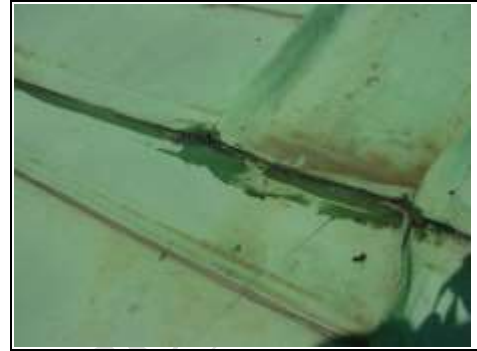
Close up of poor quality mastic repairs

Although the new jointing/mastic compounds will have been tested, from a surveying point of view the jury is still out until we have seen a product used for a good fifty plus years! We cannot therefore confirm one hundred percent that the new jointing/mastic compounds will work but from what we have seen they seem to have more flexibility than older jointing materials and as such should be able to accommodate the movement in a property.

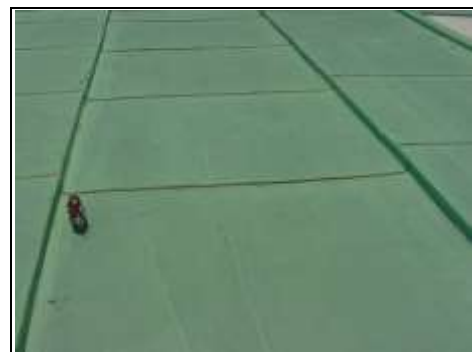
Horizontal lap joints

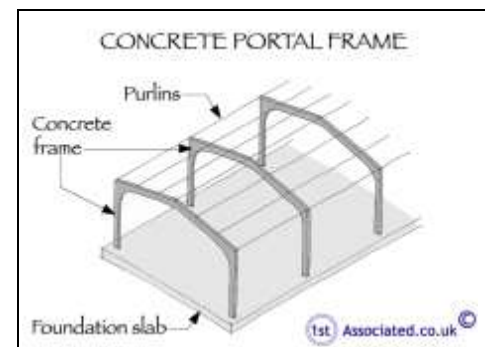
Cold bridging to portal frame and also to the ridge of the roof

These cold elements then attract general dirt, dust, skin particles etc within the environment and then blackening occurs. This blackening we believe is therefore a result of cold bridging rather than roof leaks.

To reduce the cold bridging (it is very difficult to resolve unless we have full details of what the roof is constructed of and/or open up the roof and understand how you use the building) but in general this will involve:-

- 2.3.1) increase ventilation
- 2.3.2) review the way the church is heated
- 2.3.3) improve maintenance

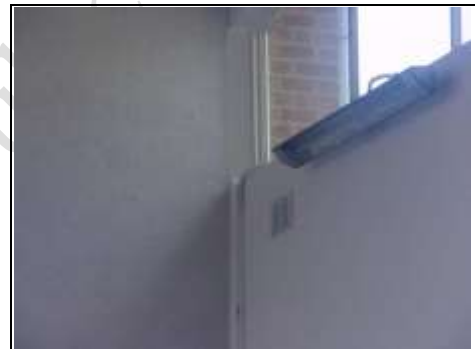
Air vent at rear
(high level electric heaters we
were advised are not working)

ACTION REQUIRED: We would recommend additional vents are added at high level and in addition to this we would also recommend that the fascias and soffits have vents added too.

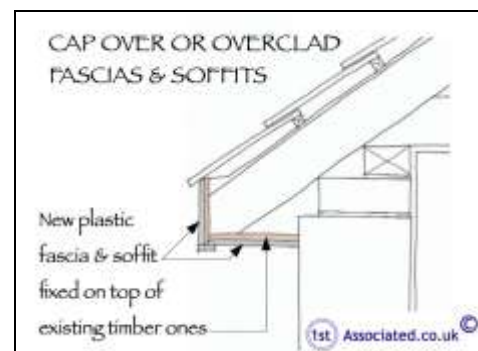
We believe that the fascias and soffits have been overclad which is not ideal vents need to be added as shown in our sketch.

Fascias and soffits, add ventilation into fascias however we would never recommend overcladding existing fascias and soffits and ideally this should be replaced rather than what we believe to be stick on fascias and soffits

ACTION REQUIRED: Vents need to be added to the overcladding which has occurred to the fascias and soffits. Please see our article on over cladding and cold bridging in the Appendices.

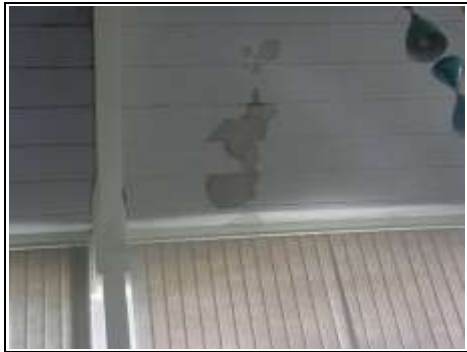
Staining to the roof

The damp staining to the fibre tiles we believe relates to dampness coming in through the roof. Unfortunately their location internally does

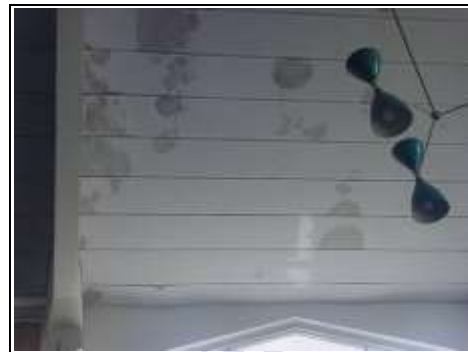
Spot/patch staining to the roof

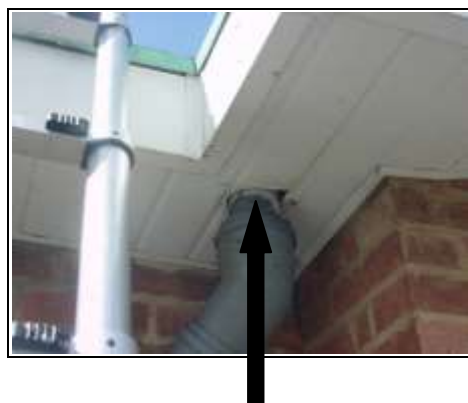
Downpipe outlet is still too small

We can see that the guttering has been altered over the years and as such the openings in the downpipes are not as wide as they should be.

Open up the downpipes to the full width to meet the internal gutters and have more regular clearing of gutters.

ANTICIPATED COST: In the region of £500 to £1000 (five hundred to one thousand pounds); please obtain quotations.

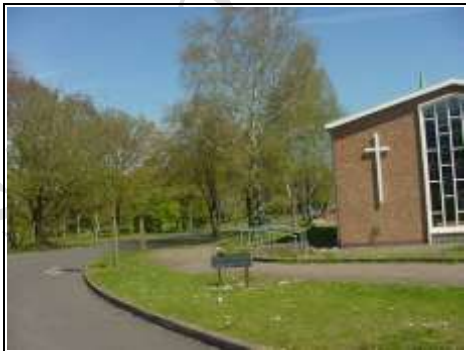
Trees higher than the Church on the left hand side

We recommend discussions with the Local Authority to see if they will maintain the trees more frequently, the trees are now higher than the church and as such any leaves etc will land in your guttering.

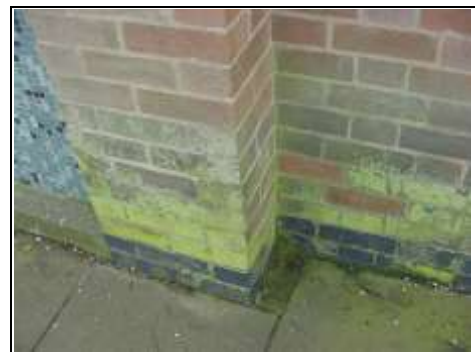
Greening of brickwork to the left hand side

The greening of brickwork to the left hand side is believed to be caused by overflowing gutters and, in our opinion, is likely to have been partly due to lack of sunlight caused by nearby trees

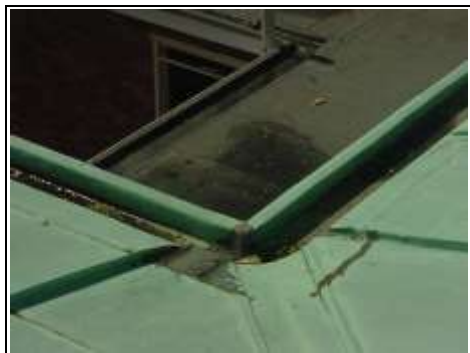
Mastic repairs to main roof internal gutter

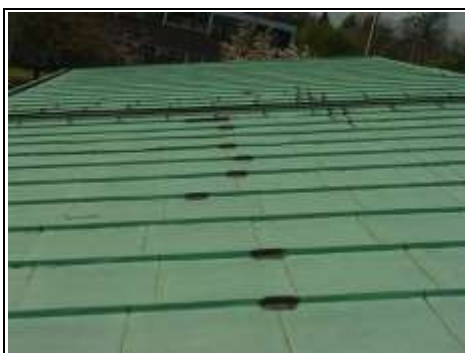
Repairs to main roof right hand side

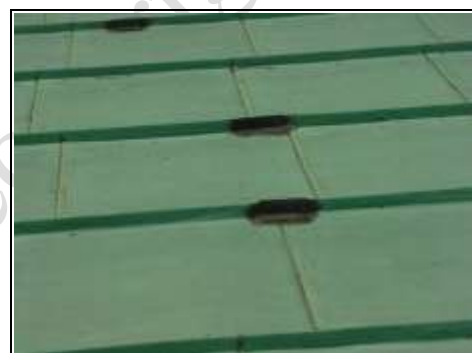
Close up view of repairs to main roof right hand side

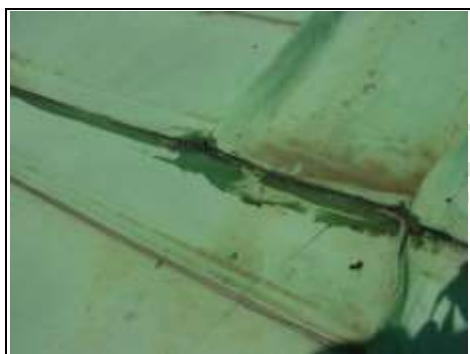
Poor quality mastic repairs

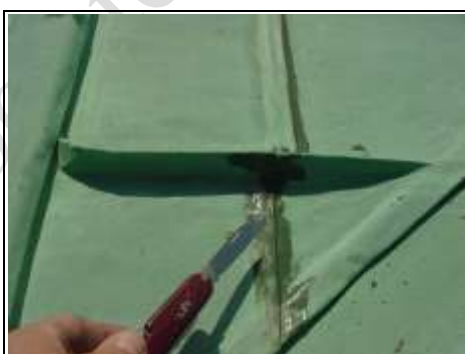
Example of painting over the joint rather than opening it up and carrying out a repair

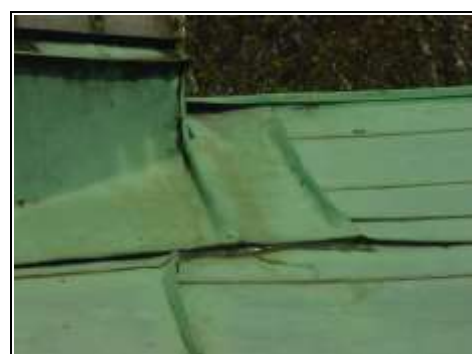
We noted areas of repair but no visible signs of problems

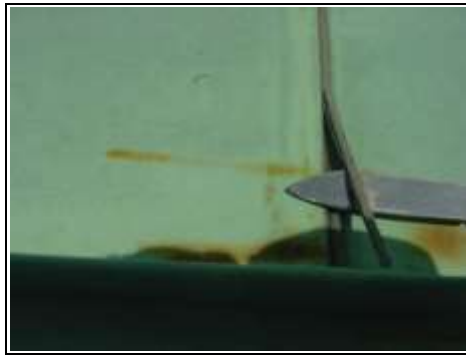
Original seals starting to deteriorate

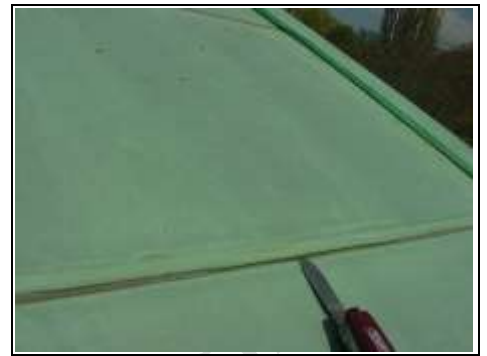
Seal missing

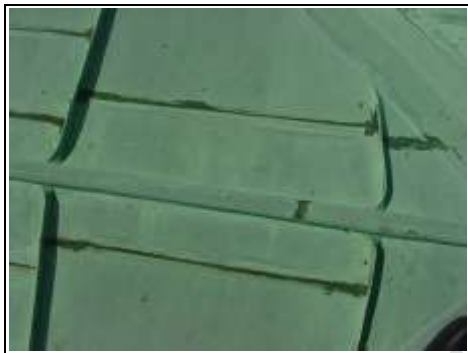
Repairs to ridge

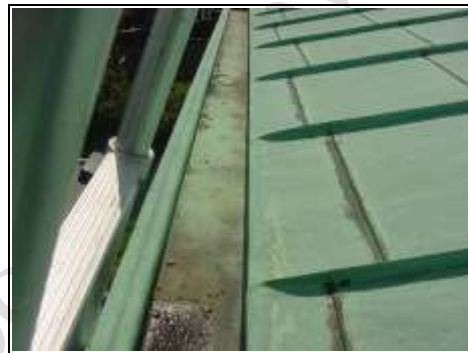
Internal gutters are relatively clean and show that there is a fall and no ponding within them (unlike your flat roofs)

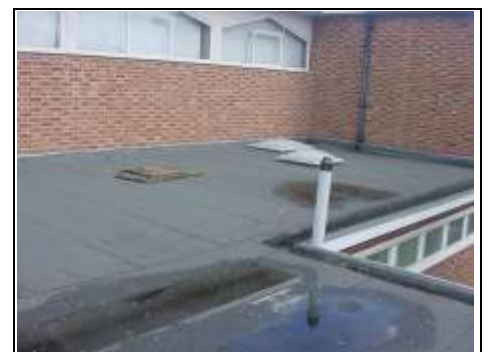
Excessive ponding and rainwater in internal gully

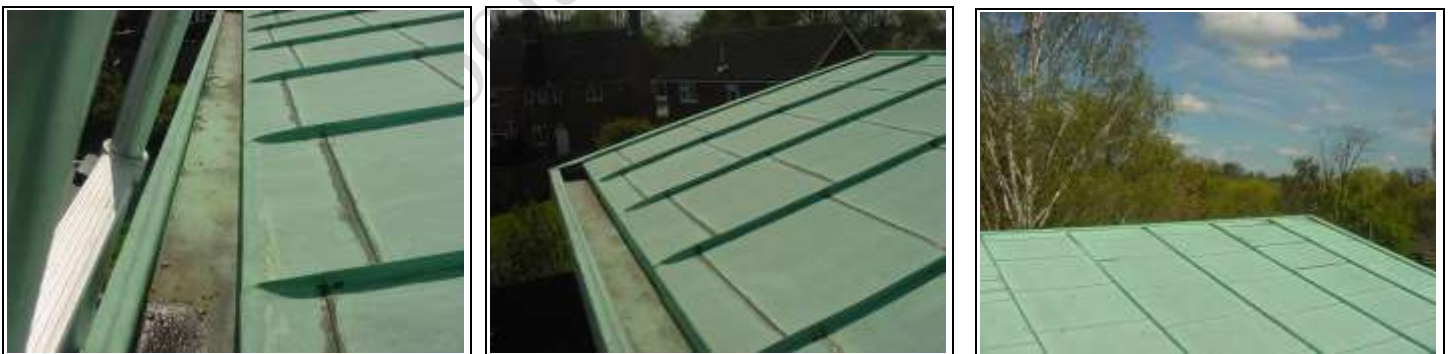
On the left hand side the internal gulley's are affected by the trees.

Trees close by

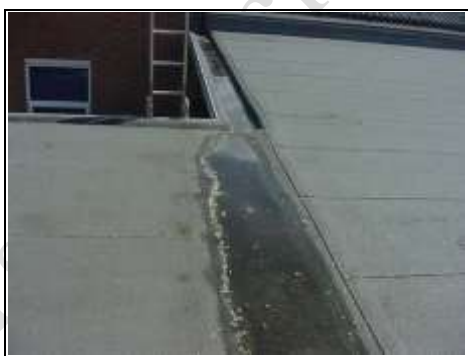
Rainwater is able to sit in the internal gulley's to the rear flat roof

Rainwater sitting in internal gulley

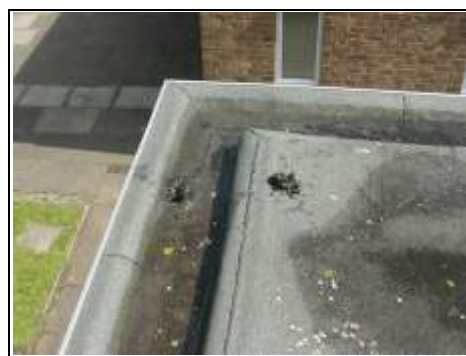
Rear flat roof gulley left hand corner which we unblocked during the course of our survey
