SPECIFIC DEFECTS REPORT

**Relating to dampness
from various roofs**

STAFFORDSHIRE

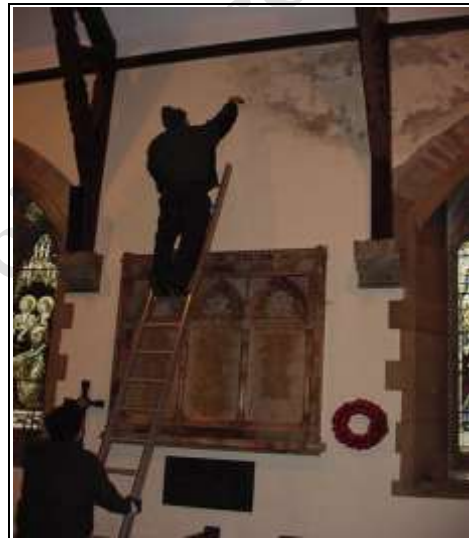
Deterioration to the South Aisle

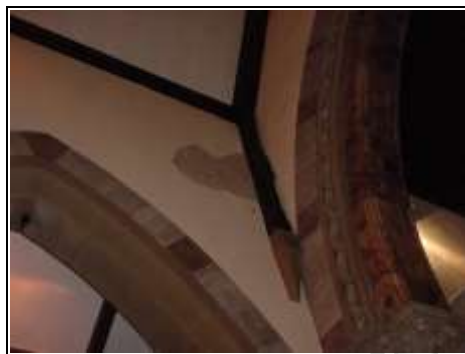
Deterioration to the North Aisle

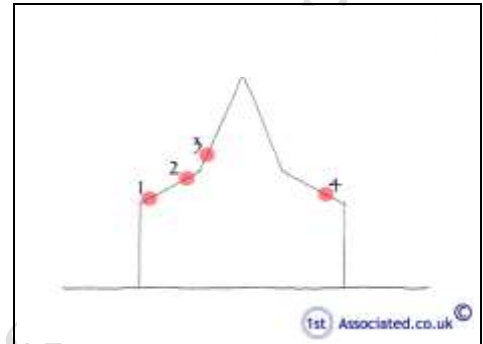
There is also opening up to the main Nave roof at low level. In each case there were areas of tiles removed in areas 1, 2, 3, and 4 as shown in the adjoining sketch.

There was a sample taken at point 4 as noted in the above sketch.

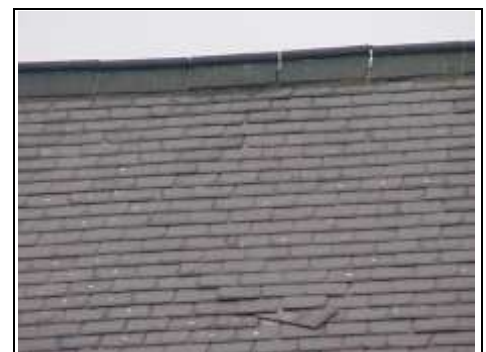
The slate roof showed approximately ten to twenty percent of slipped slates. We are advised from discussions with contractors that these are copper nailed and if fixed properly should give a long life. We also noted that the ridge was starting to deteriorate.

Slipped slates and deteriorating ridge tiles.

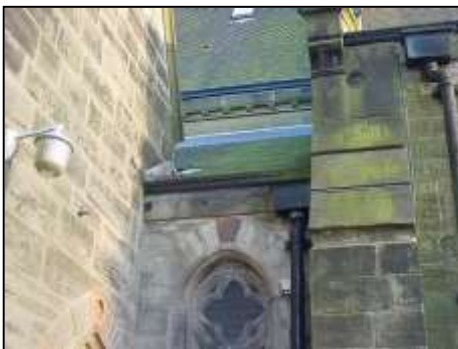
The current gutters look to overflow (although it was not raining at the time of our survey so we cannot be certain). We feel a larger hopper head should also be provided.

Overflowing valley gutter to north door entrance

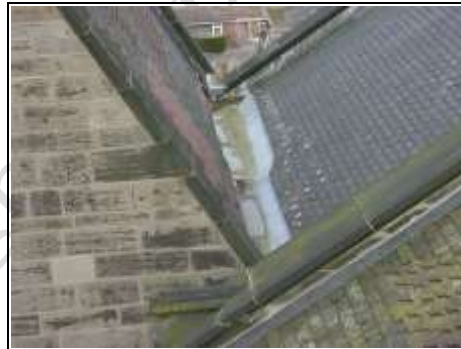
It also looks as if lead tingles have been used possibly indicating problems with the slate roofs.

Valley gutter with lead tingles to the central area

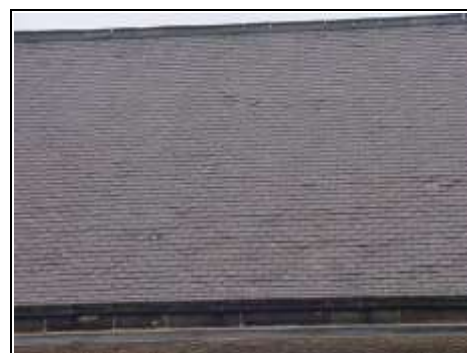
Close up of ridge, needs re-bedding

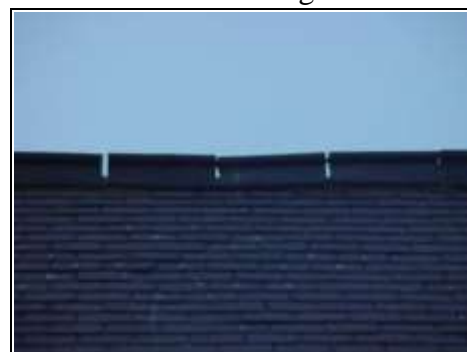
Nevertheless there is, as can clearly be seen, problems with slipped slates. We would have expected to see some tingles if the nail fixings had rusted. Please see our previous comments on tingles.

Overview of slipped slate to the south elevation

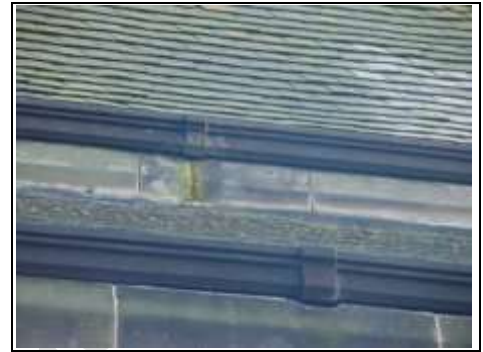
We feel a weak area with regard to both sides is the design detailing where the gutter sits on the wall and a close up visual inspection needs to be made.

Leaking gutter sitting on a wall.

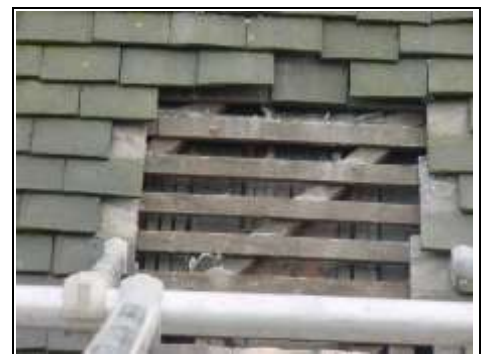
Battens and underlayer exposed on north elevation high level roof

We would expect extensive work to the north elevation partly re-roofing and re-battening and with the adding of a modern protective underlayer. The work will be carried out during the summer months.

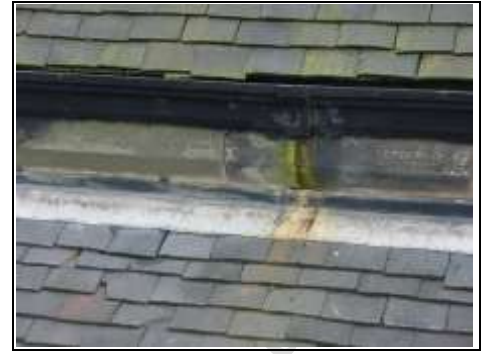
Leaking gutter

Again we will look at the flashing and guttering details.

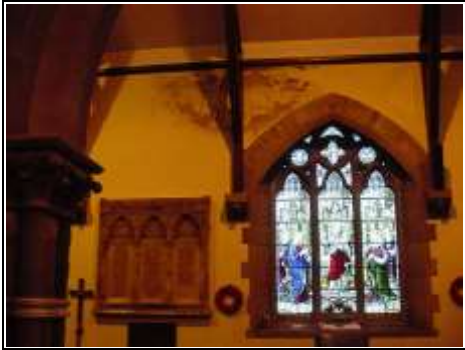
South aisle with efflorescence and dampness at high level

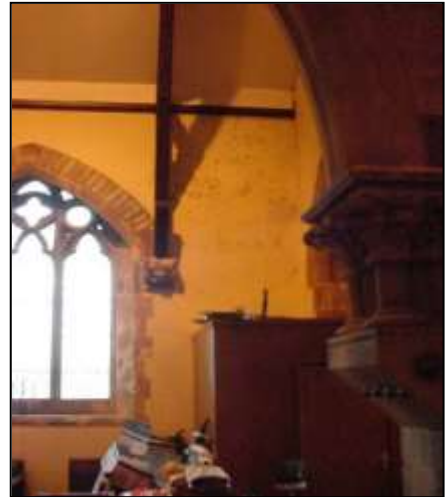
Front of the south aisle with efflorescence at roof level

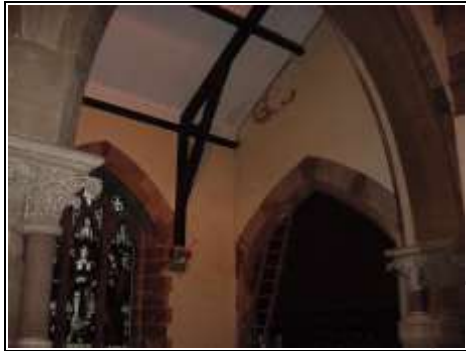
High level dampness to the Vestry side of the church

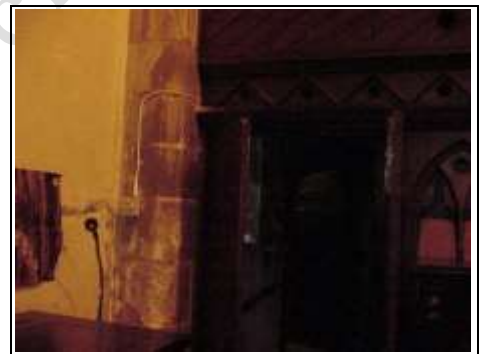
Low level dampness to the north aisle

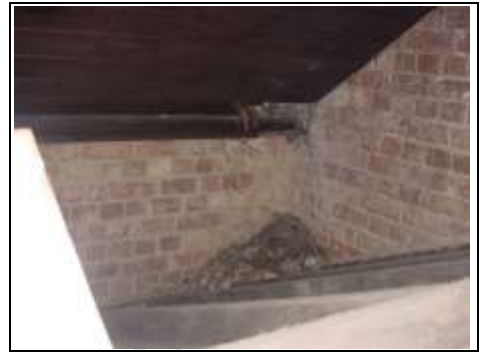
There has been some
disturbance of the roof
