COMMERCIAL BUILDING SURVEY AND PROPERTY APPRAISAL

**Large Building to be used for
Commercial Use in
Chingford
London**

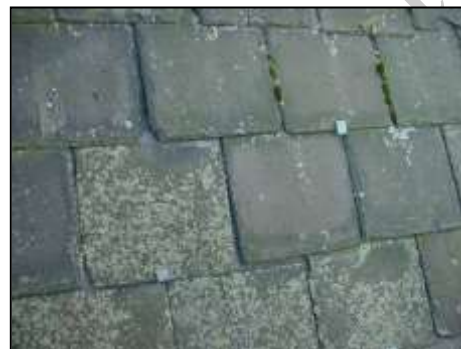
The main roof is clad with slates. We can see there have been various repairs using lead tingles. These indicate that the nail fixings are rusting, often known as nail sickness. We generally recommended where there are more than a dozen to two dozen tingles visible that re-roofing is likely in the near future, which is the case in this instance.

Close up of slates showing lead tingles to front of building

ACTION REQUIRED: Re-roof over next few years. There are no major visual signs internally (to the ceilings) that the roof is a problem. Having said that, we have not been in the actual roof space of these areas.

ANTICIPATED COST: In the region of £100,000 to £150,000 to re-roof or carry out major repairs. You need to obtain quotations, quotes will depend on whether you scaffold over the property to form a temporary roof or take the risk that there won't be adverse weather whilst you are carrying out the work.

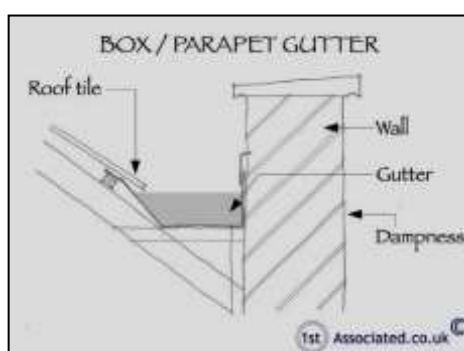
To the front of the property where we could inspect it, we found a box gutter. This we believe is allowing dampness into the walls.

ACTION REQUIRED: You will need to regularly clear this roof of leaves and debris. As you have trees surrounding the property this will be a constant requirement.

ANTICIPATED COST: Included in the main roof works.

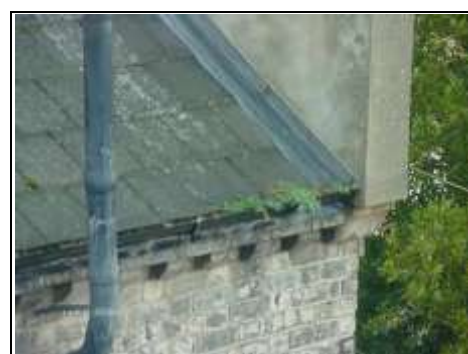
To the sides of the property we can see that the guttering sits partly over the walls. This means if/when leaks occur to the guttering dampness gets into the walls. This often takes a while to be visible and become more visible when a building is properly occupied as the warmth of the building draws the dampness through the walls.

Blocked gutters and vegetation growing

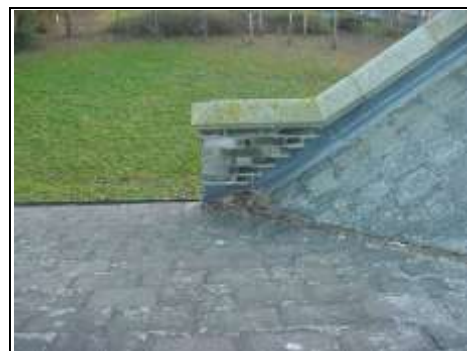
Ongoing maintenance battle against the leaves and branches blocking the gutters up on the roof

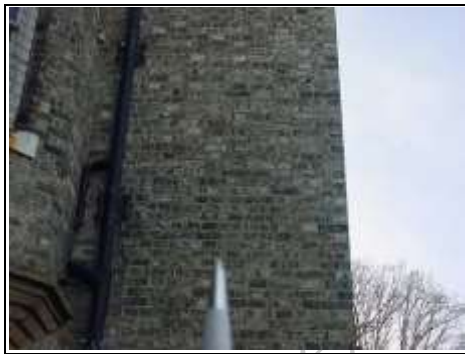
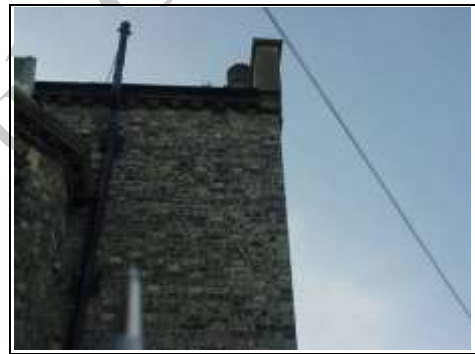
4.1 Vertical cracking – right hand wing

vertical crack running through the bricks to the length of the property.

Vertical cracking to right hand wing

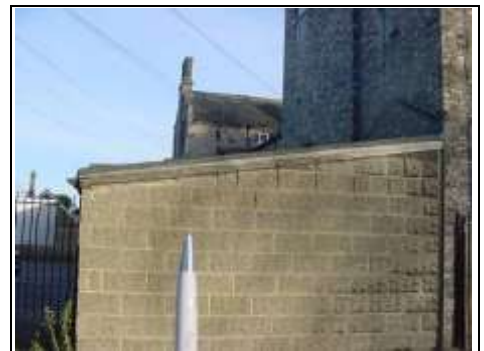
4.2 There is also cracking in the new single storey extension on the right hand side indicating that movement is still occurring. We can also see cracking internally in this section.

Cracking in single storey lean-to
Right hand wing

ACTION REQUIRED: A buttress type structure may be needed to hold this wall in place together with tying in of the floor and roof structure.

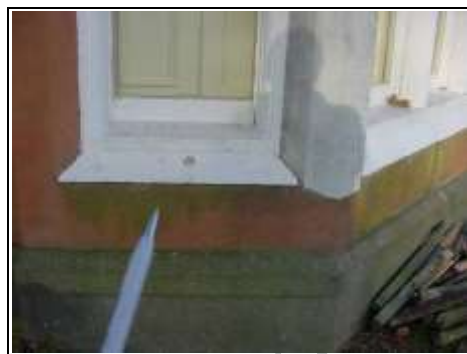
Movement in double bay to rear at low level

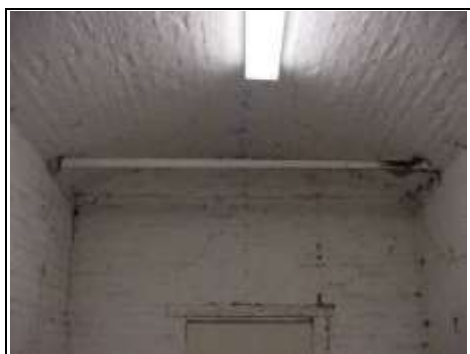
Lots of cracking in adjacent room to the clay store area

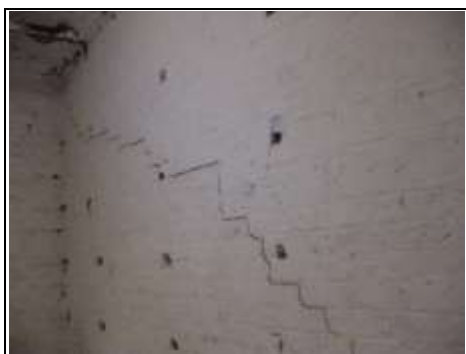
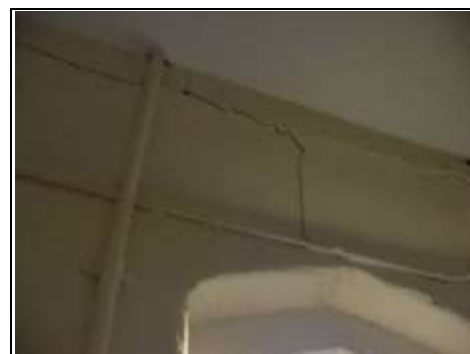
Cracking to lobby at top of spiral staircase

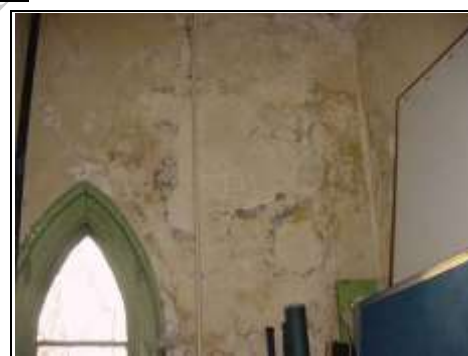
Dampness through walls, known as lateral dampness, visible particularly to pottery rooms and also the right hand elevation where the gothic window is visible. This may be due to the adjoining tree in that instance.

Dampness

ACTION REQUIRED: we believe that the repair work recommended to the gutters and downpipes and the repointing will reduce this to a manageable standard as a certain amount of damp is considered acceptable within older properties such as this.

ANTICIPATED COST: Already budgeted with regard to external repairs. We would additionally add £25,000 to £50,000 for internal repairs. We have kept this figure high as we feel that some of the work may be required to the Listed Building section of this property. Please obtain quotations.

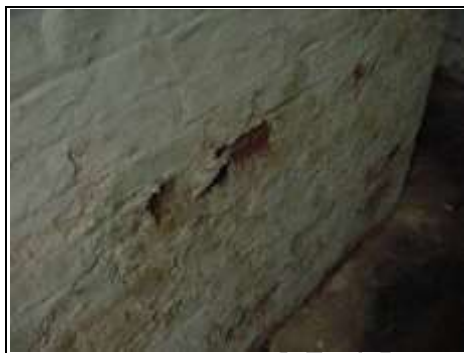
There is rising damp throughout the property. It was particularly noticeable in the basement/cellar area where we would expect there to be dampness. It is also visible in the left hand corridor at ground floor level. We feel it may also be present in other ground floor rooms, although there is timber panelling that may be hiding it. Spalling to brickwork from dampness

ACTION REQUIRED: We feel some form of French gully around the property would be the best way of reducing the dampness and managing the dampness but this only needs to be carried out once investigations have taken place. We recommend the property is monitored for at least a year.

ANTICIPATED COST: In the region of £30,000 to £50,000; please obtain quotations.

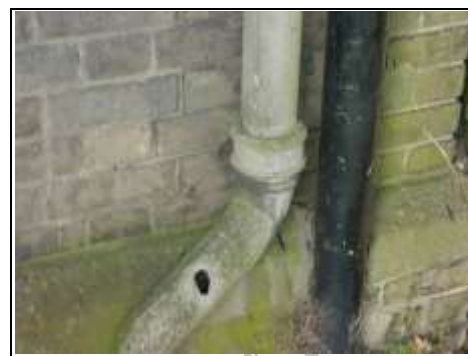
What we believe to be asbestos was found to the back left hand side of the property in the form of a pipe. In this age of property asbestos was commonly used during the refurbishments.

Asbestos pipe

ACTION REQUIRED: We would recommend an asbestos report is carried out on the property as a whole if one does not exist at the moment and that tests are carried out to establish what type of asbestos it is.

ANTICIPATED COST: Nominal sum of £10,000 - £20,000. Follow asbestos contractor's recommendations. Please note we are not asbestos surveyors.

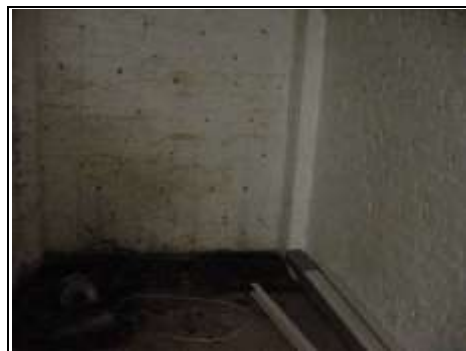
Within the basement we can see signs of dampness and past flooding. We can also see that various measures have been taken to try and reduce this. There are holes that have been drilled in most the external walls and some of the internal walls, which we believe could be acting as weep holes to allow water into the property and stop the pressure that is caused on the walls.

Holes drilled in the wall

ACTION REQUIRED: Either way you need to work out a suitable way to manage dampness and flooding to the cellar. Unfortunately we were unable to find a sump pump which we would expect to see to remove any water that gets into the cellar. This is the first thing that we would add.

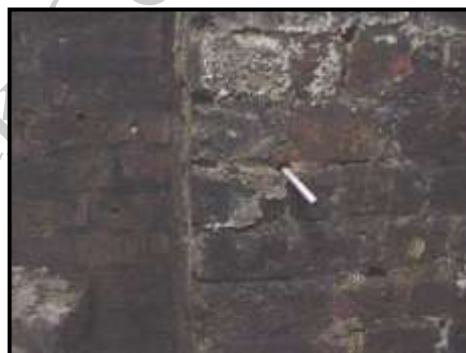
Pen indicates an example of one of many holes drilled in the wall in the basement

We would add that in the many years that we have been carrying out surveys we have never seen holes drilled in a cellar such as this and as such we would specifically recommend that your legal adviser writes requesting information with regard to any work that has been carried out to the basement area, particularly in relation to the holes.

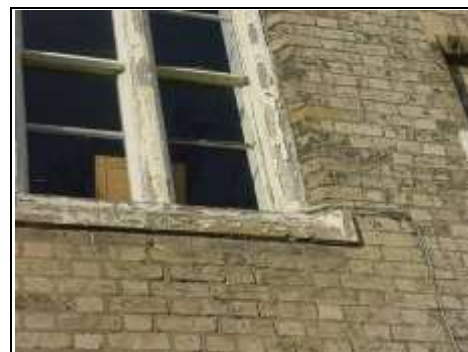
The property has a mixture of timber windows and sliding sash windows; all single glazed. We would specifically comment that bare timber is visible to many areas. We would recommend complete redecoration, although the timber is still in remarkably good condition all things considered.

Paint flaking off rear windows, bare timber visible

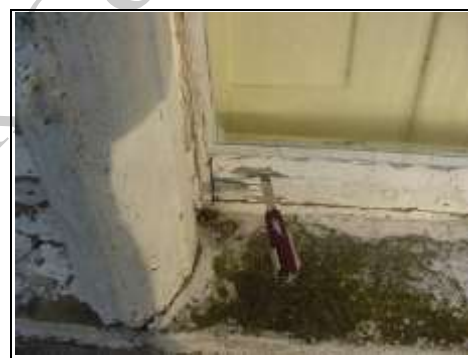
We have knife tested a sample of the windows at ground level and the quality of the original timber is still sound in most cases, although we can see that some new timber has been spliced in. We believe that these windows are saveable though this may not be the most economical way of proceeding it is the way that you most likely would have to proceed with a Listed building such as this as the Conservation Officer would have views on this matter.

Quality of windows on right hand gable

ACTION REQUIRED: Prepare, repair and redecorate.

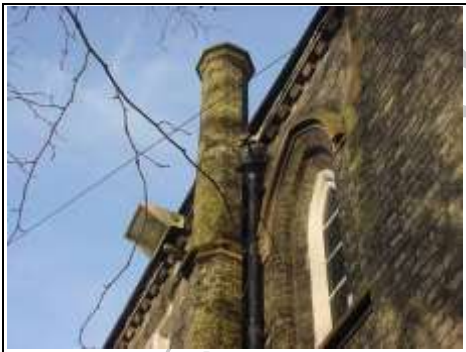
Chimney on right hand gable, overflowing hopper head causing deterioration to brickwork

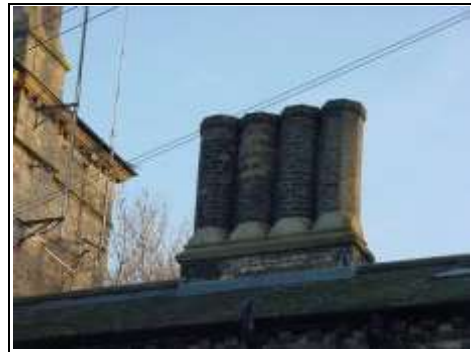
Minor spalling brickwork

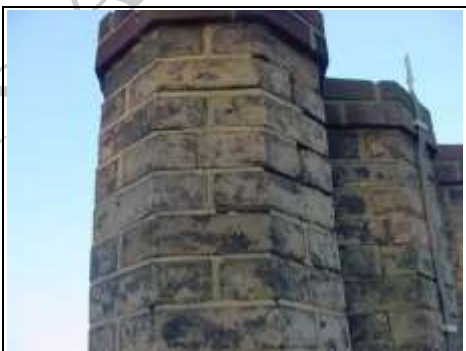
Close up showing cracking to brickwork and repointing required

ACTION REQUIRED: The majority of the chimneys will required some repointing. We noticed some work had been carried out in a hard cement mortar which may cause spalling to the brickwork.

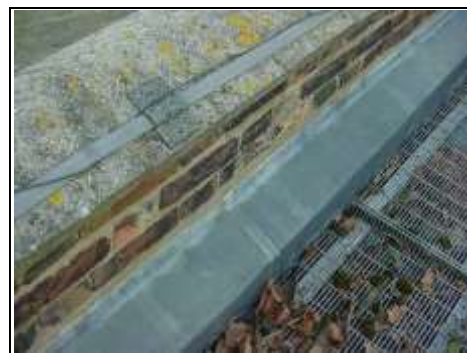
Parapet wall has been wrongly repointed in cement mortar

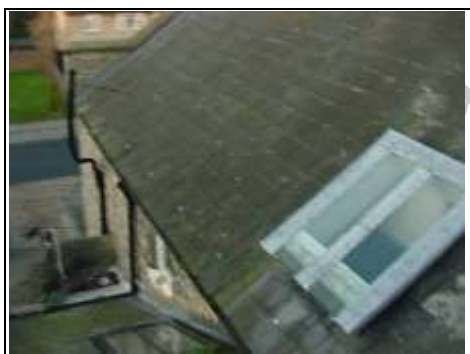
Roof light four – left hand side
Older style wood made roof window which has then been covered with lead of equivalent and tends to be more problematic than the purpose made windows

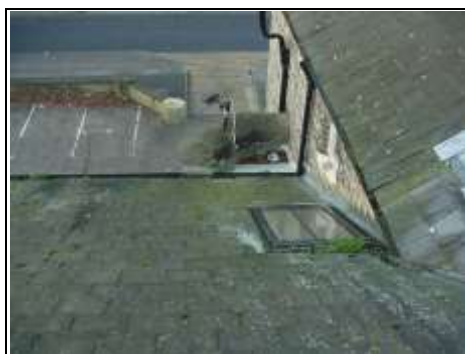
Roof light five – left hand side
This is an awkward detail with vegetation growing at the top that needs to be removed as part of your annual maintenance programme

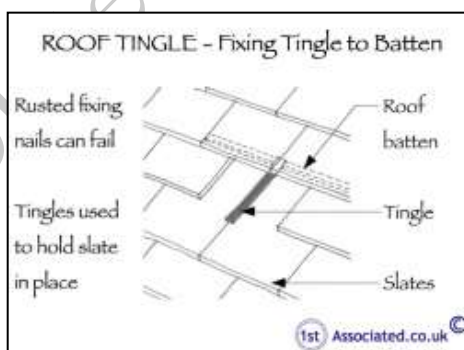
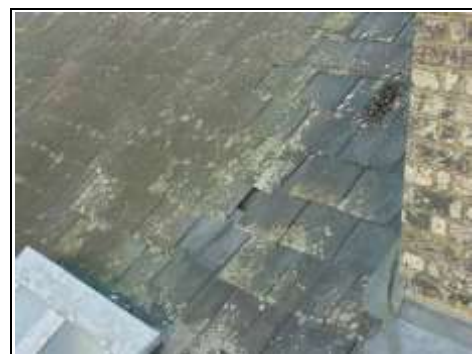
Missing slate to front left hand roof

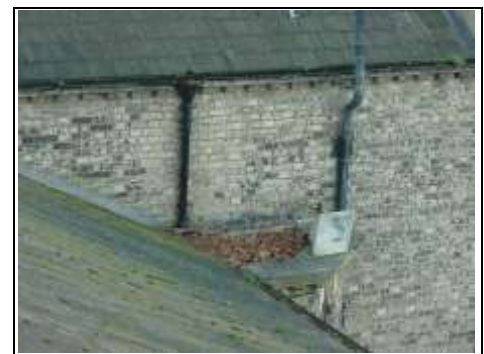
Oriel flat roof right hand side which is leaking

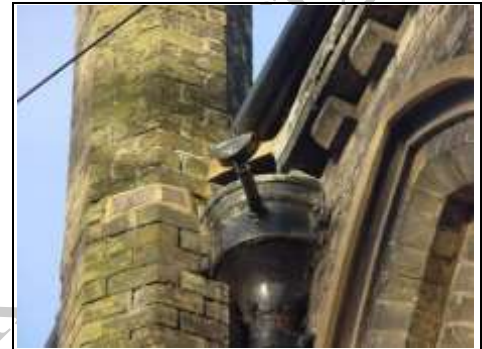
Hopper head overflowing, chimney needs repointing

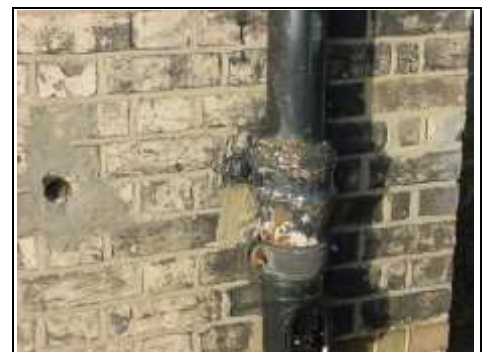
Cast iron downpipe being linked to a plastic downpipe, we assume the original cast iron has rusted away

Cast iron rusting away

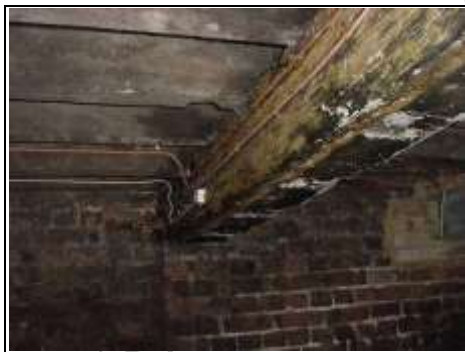
Spine beam

We can also see a spine beam within the basement to the front left hand side and can also see that many of the timbers have rotted away and been replaced which is partly why there is cracking in it.

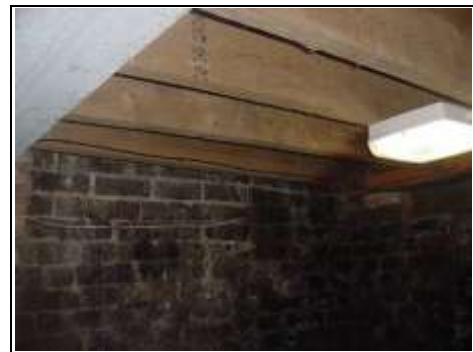
Replacement timbers

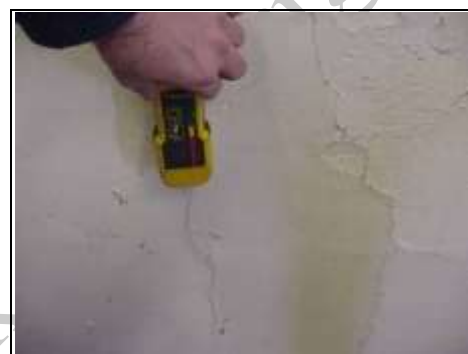
We used a damp meter on the external walls. We have found dampness, particularly to the front and right hand side of the property but we believe it is present throughout it is just hidden in some areas by such things as the wall panelling.

Dampness to front of property
