SPECIFIC DEFECTS REPORT

**Relating to Concrete Sample Testing
Hertfordshire**

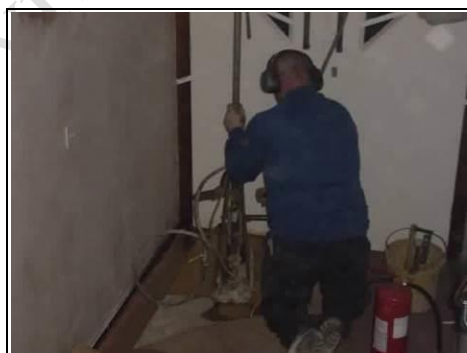
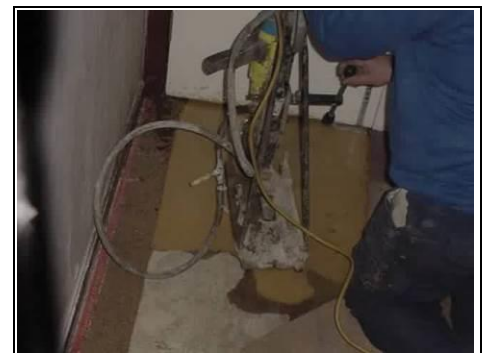
Example of first core sample being taken from the basement

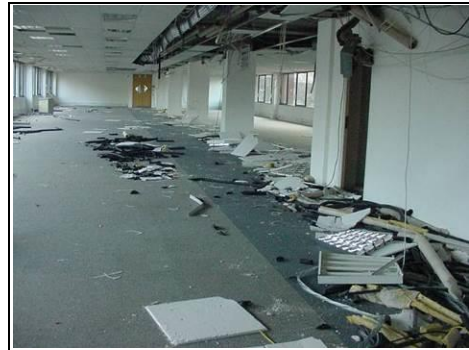
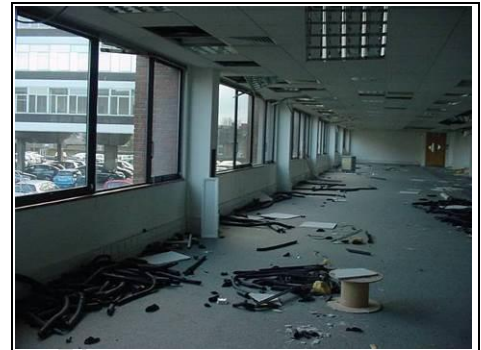
Internal stripped of precious metals

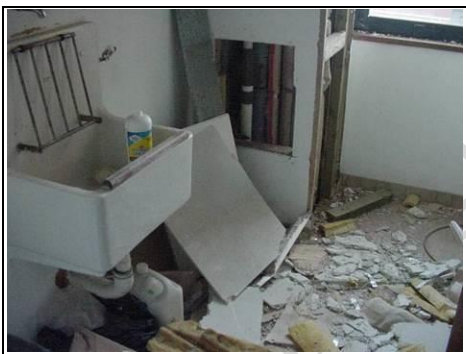
Service cupboard where core samples have been taken at ground floor, first floor and second floor

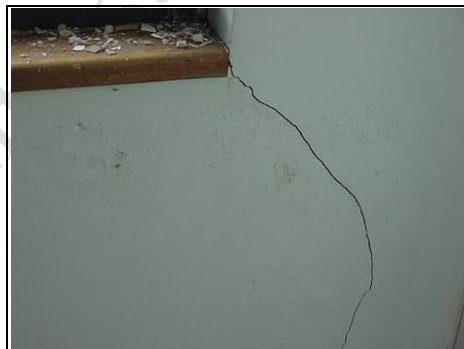
Cracking

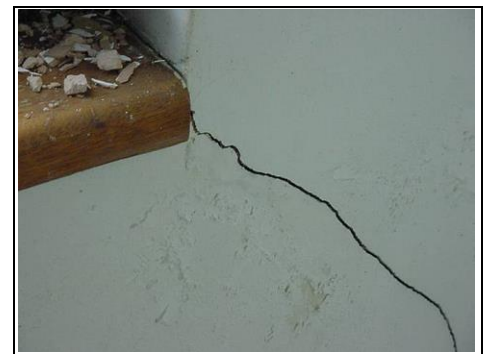
Close up of cracking

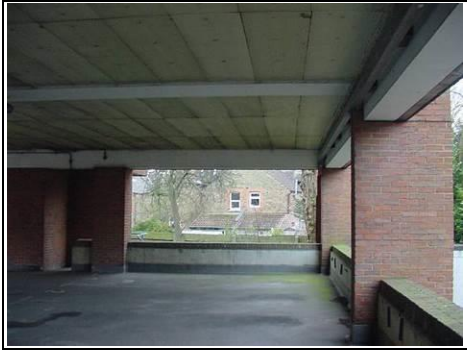
Ground floor rear parking area –
first floor concrete frame and floor
slabs visible

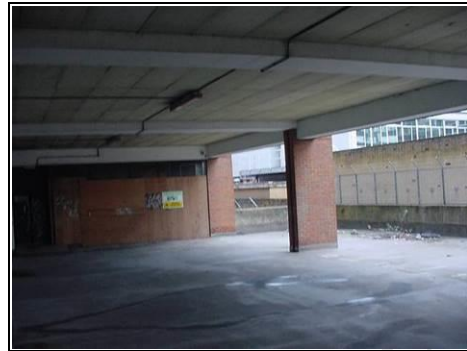
Concrete frame visible to basement
area

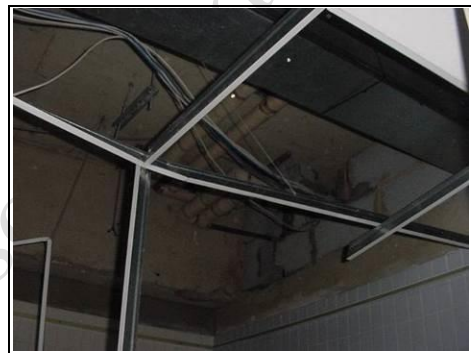
Ceiling down in gents toilets
