SPECIFIC DEFECTS REPORT

**Relating to dampness
from various roofs**

STAFFORDSHIRE

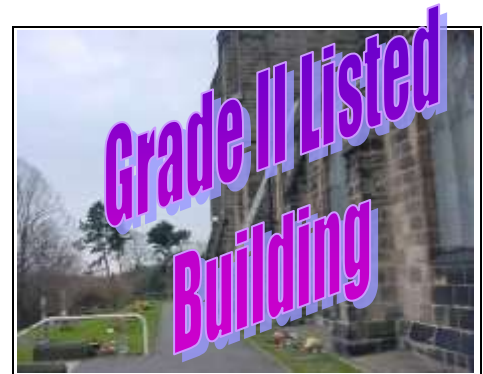
South elevation roof accessed via ladder

The slate roof showed approximately ten to twenty percent of slipped slates. We are advised from discussions with contractors that these are copper nailed and if fixed properly should give a long life. We also noted that the ridge was starting to deteriorate.

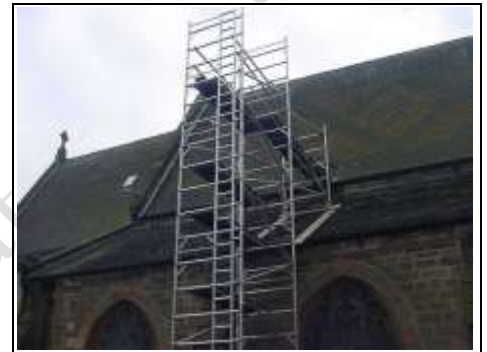
The areas inspected on the North Aisle roof and the lower part of the Nave roof generally showed the battens in the worst condition. The roof tiles were clay and concrete in this instance. We also noted areas where the gutters were not watertight.

Our main concern in this area is the condition of the battens.

North elevation roof accessed via tower scaffolding.

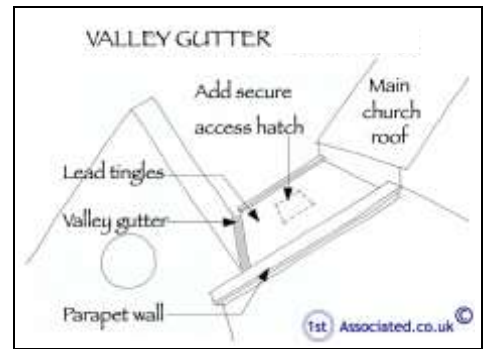
There is a problematic area to the north east aisle roof that forms a valley gutter. This is above the Vicar and Choir Vestry areas and needs specific attention and further investigation. However from what we saw we feel it needs a change in the design.

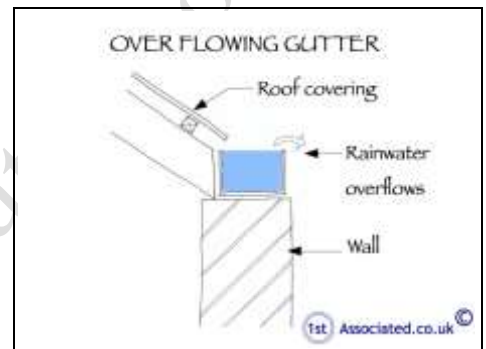
The current gutters look to overflow (although it was not raining at the time of our survey so we cannot be certain). We feel a larger hopper head should also be provided.

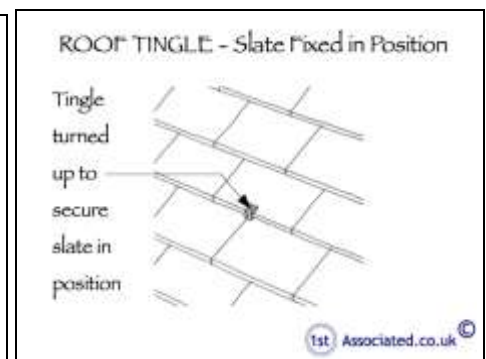
It also looks as if lead tingles have been used possibly indicating problems with the slate roofs.

Valley gutter with lead tingles to the central area

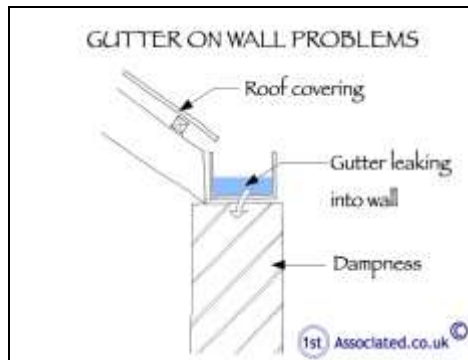
We feel a weak area with regard to both sides is the design detailing where the gutter sits on the wall and a close up visual inspection needs to be made.

Leaking gutter sitting on a wall.
