COMMERCIAL BUILDING SURVEY AND PROPERTY APPRAISAL

**Large Building to be used for
Commercial Use in
Chingford
London**

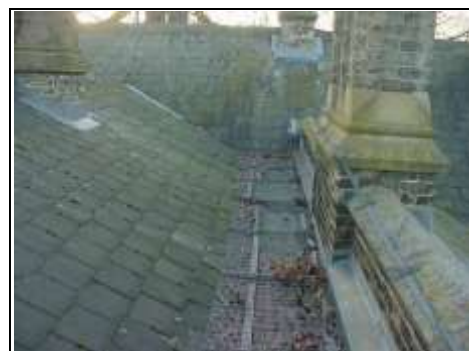
To the front of the property where we could inspect it, we found a box gutter. This we believe is allowing dampness into the walls.

General view of roof showing box gutters

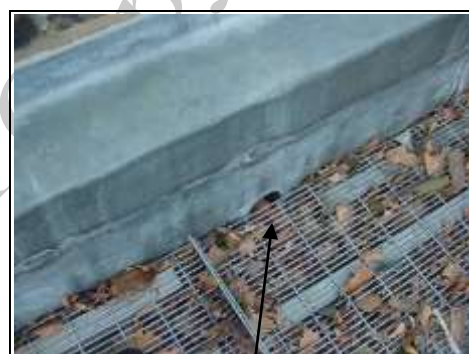
Example of how the box gutter gets blocked with the arrow showing where the outlet is in the parapet wall to the front of the property

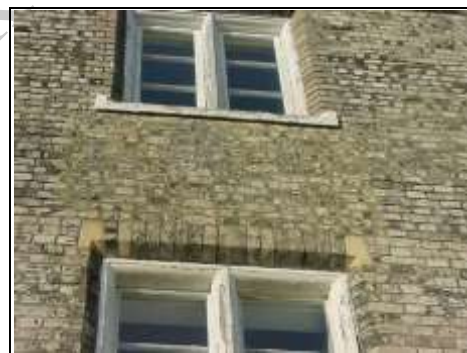
Weathering has occurred particularly to the rear left hand side under the windows and also where it is overflowing from gutters and hopper heads and downpipes.

Weathered brickwork

ACTION REQUIRED: The process needs to be clearing of the gutters and roofs of debris and a regular planned maintenance programme be adopted. Then to check the gutter joints, checking that they fall and their lining, tarring if necessary to the downpipes, and only then to re-point in an appropriate lime based mortar to the correct pointing style to the external of the property.

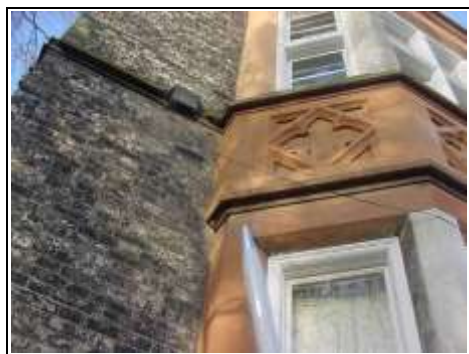
4.3 Movement in rear double bay window

Movement in double bay to rear at high level

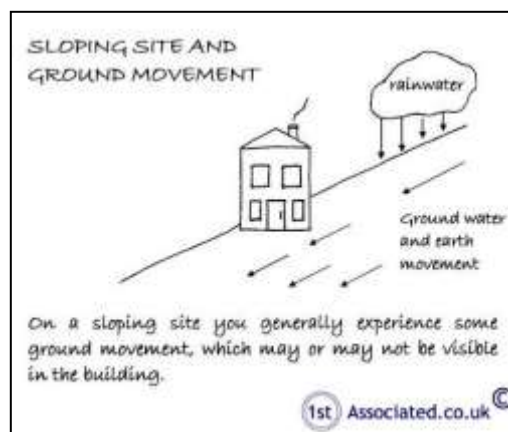
Sloping Site

Whilst the sloping site is not pronounced there is a fall from the front elevation of the property to the rear of the property and as such water would wish to pass from one side to the other, which we believe it is presently doing through the basement.

The sketch obviously over-emphasises the slope in this instance.

ACTION REQUIRED: Please note our comments with regard to the basement and the holes in there and managing the ground water around the property.

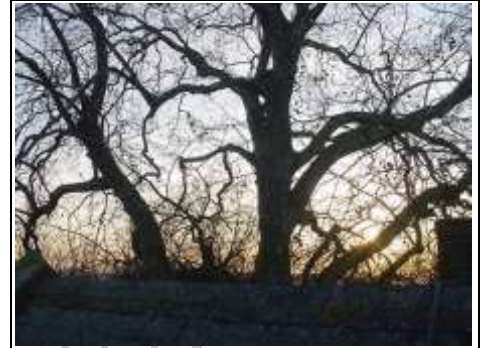
Trees need regular maintenance

ACTION REQUIRED: Carry out regular maintenance.

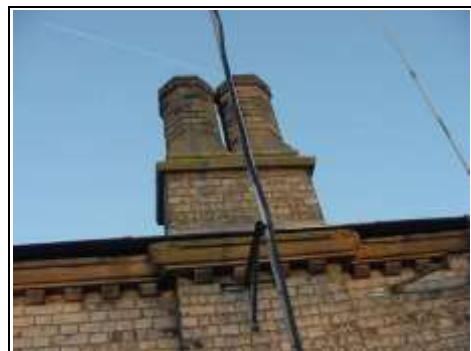
We were unable to get a close up view of some of the chimneys

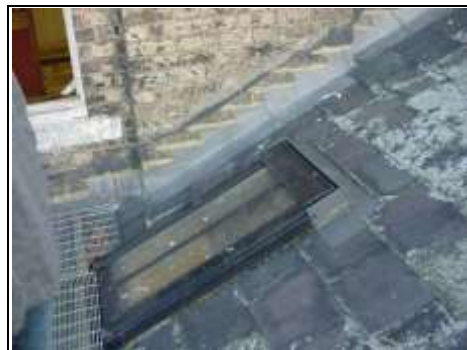
Roof light one – main building left hand side front

The majority of the roof windows are a modern factory and purpose made style, which looked in average condition. The important factor with roof lights is the flashings around them. We could see one case (roof light five) where vegetation was growing to the top of this and needed clearing.

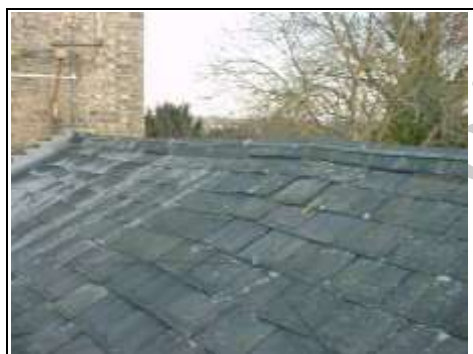
Left hand roof

The roof is pitched and clad with slates, with box gutters. From ground level and front roof level this looks in average to below average condition considering the roofs age type and style.

We were able to access the front roof and inspect this more closely where we could see lead tingles were present, as well as there being some cracked and slipped slates.

ACTION REQUIRED: We feel that the roof may have nail sickness, which is the rusting of the nail fixings. Please see our comments in the Executive Summary.

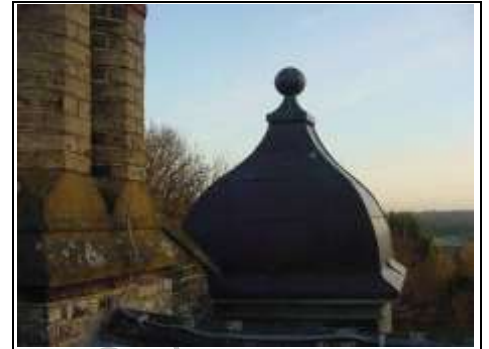
Rear turret

We were pleased to see the turret roof to the rear looks relatively new.

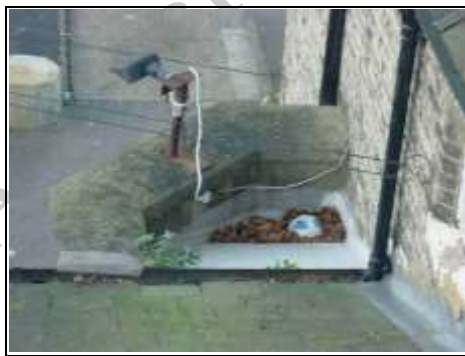
Left hand Oriel roof

As you can see in the photos these are collecting a lot of leaves and this needs to form part of your regular maintenance programme. Equally you can see there is difficulty in accessing this area.

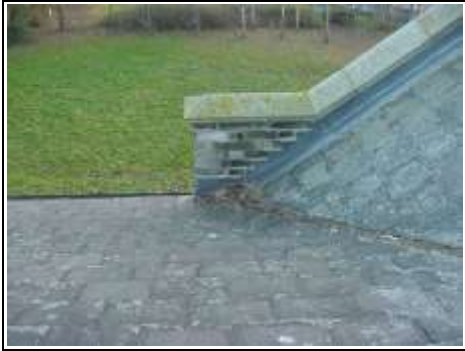
As with many roofs that have been extended and altered over the years you have some awkward details that simply need regular maintenance. The problem is that regular maintenance tends to be forgotten about in the scheme of things.

Blocked valley gutter

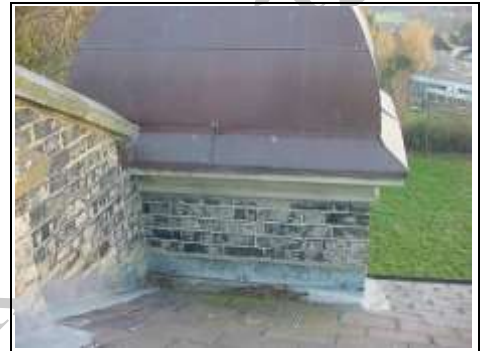
Natural areas due to the way the roof has developed that are awkwardly detailed, such as this one with the rear turret roof being a trap for leaves and water

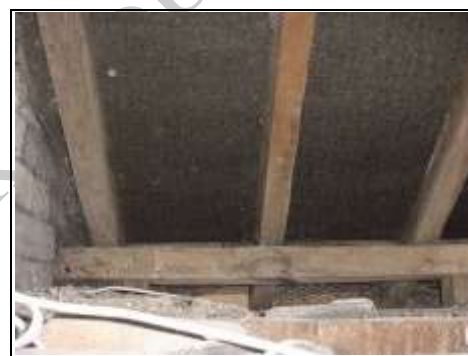
Protective underlayer

When we inspected the loft space we found a Hessian base Bitumen membrane. This type of membrane has been used since the 1960s. We generally found it to be in average condition, it is damaged in a few more places than we normally find. We also noticed the darker timber indicating dampness getting in.

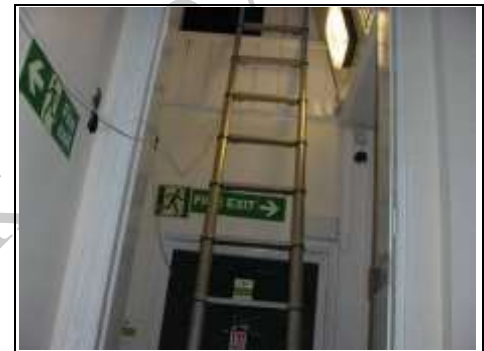
One area is adjacent to Room 14 and the other was from within Room 18. There is no loft ladder or electric light in either of the roofs. There was some secured floor boarding in roof adjacent to room 14. We recommend a general upgrade in the access to the roofs.

Access to roof adjacent to room 14
(old numbering)

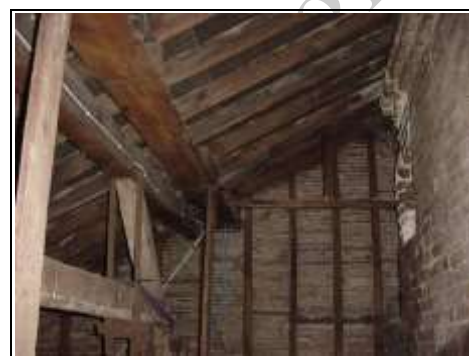
Roof visible from within access adjacent to room 14

Our examination was limited by the general configuration of the roofs. What we could see in this roof was average to below average, with dampness visible around chimney for example and signs of woodworm. It is, however, feasible there are additional problems in the roof that are hidden from view, particularly as we have only seen approximately thirty percent of the roof structure.

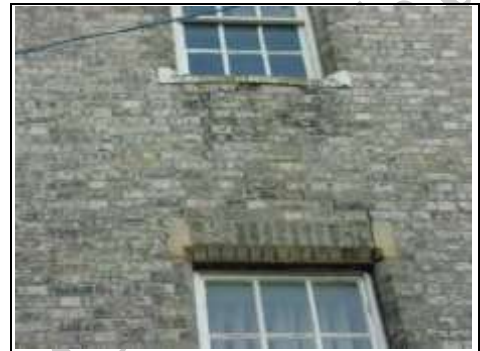
External picture of brickwork

The property is built in a brick originally in a lime mortar in what is known as Flemish bond brickwork which has been repointed with cement mortar. We would recommend a programme of gradually re-pointing the whole of the property.

ACTION REQUIRED: We would recommend a programme of repointing the whole of the property.

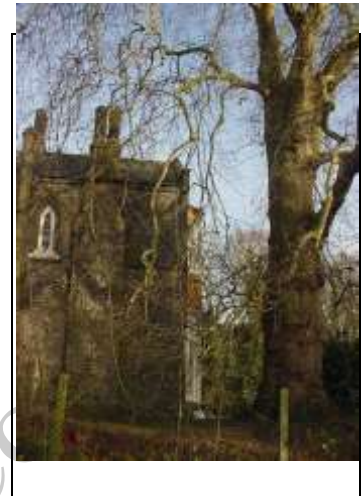
Tree on far right hand side

It is typical we find that the trees around older properties have Tree Preservation Orders on them.

ACTION REQUIRED: Your legal adviser to check and confirm.

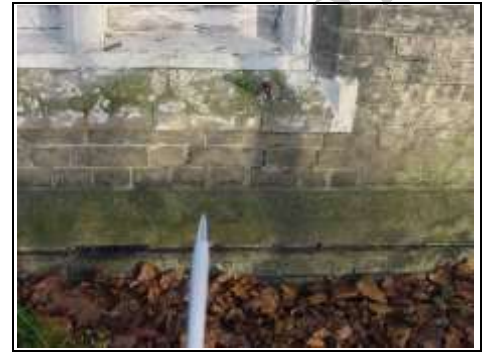
All modern properties should incorporate a damp proof course (DPC) and good building practice dictates that a differential of 150mm (6 inches) should be maintained between the damp proof course and ground levels. In this case, we can see a plinth that looked to be concrete around the property.

Plinth around property.
Also note deterioration to
brickwork

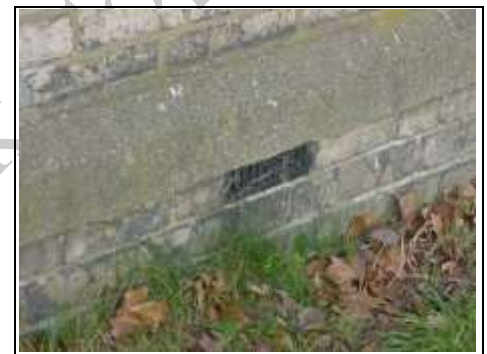
Airbricks that lead into cellar

ACTION REQUIRED: You need to ensure that all air bricks are clear and allowing a flow of air to minimise dampness and you do have a lot of dampness in the cellar.

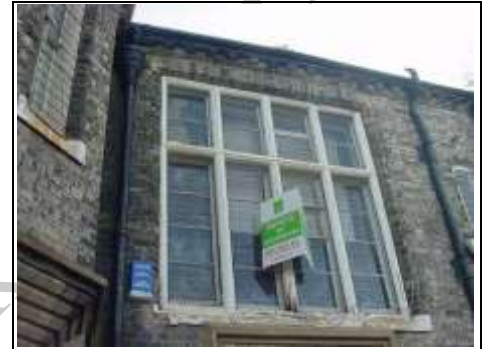
Fascia and soffit is hidden behind the guttering

As we have noted, the gutters are blocked with leaves and other tree debris so we feel they will be overflowing. We can see to the rear that they have overflowed to such an extent that they have weathered the pointing to the brickwork. It seems therefore very likely that the timber behind the gutters will also have been affected.

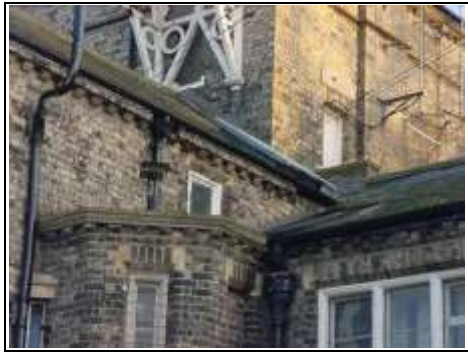
Oriel window on left hand side

The way we have used this term is strictly not architecturally correct. We have used it to identify the windows to the corner of the front of the property that look out over the front of the building. Our main concern with this area is the flat roofs and the difficulty of access to them rather than the windows themselves, which are suffering in the same way as the majority of the windows from the lack of redecoration.

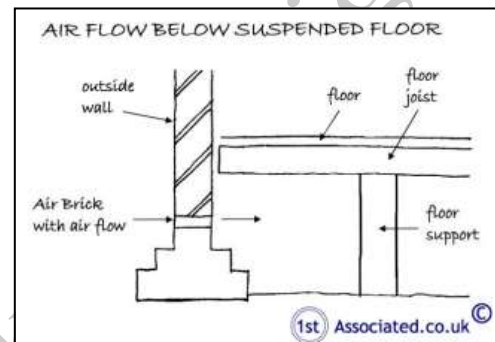
We can also see a spine beam within the basement to the front left hand side and can also see that many of the timbers have rotted away and been replaced which is partly why there is cracking in it.

We believe it would be prudent to open up sections of the floor adjacent to the walls to check the condition of the timbers in these areas as this could be one of the contributory factors to the movement in the property.

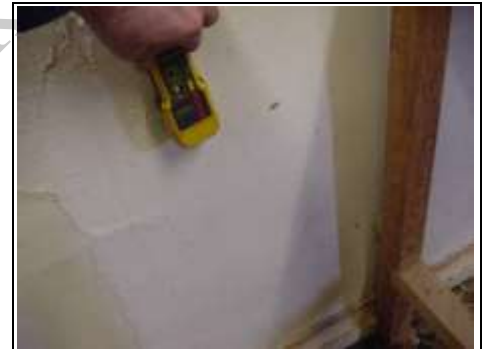
A random visual inspection and tests with a moisture meter have been taken to the perimeter walls. In this particular case we have found rising damp throughout the property.

Finding rising damp

ACTION REQUIRED: Please see the Executive Summary.

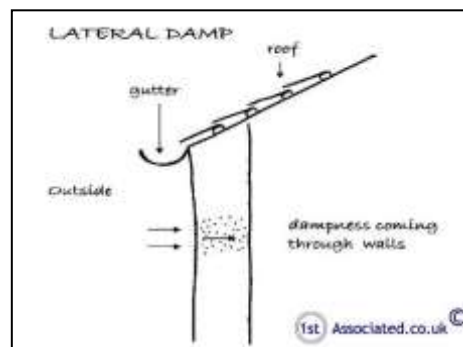
We used a damp meter on the external walls. We have found dampness, particularly to the front and right hand side of the property but we believe it is present throughout it is just hidden in some areas by such things as the wall panelling.

ACTION REQUIRED: Please see our comments in the Executive Summary.

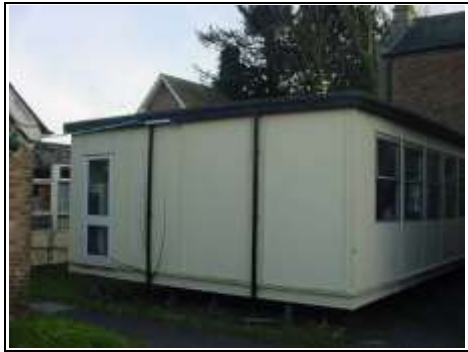
Portakabin that is being used as the kitchen
at time of inspection

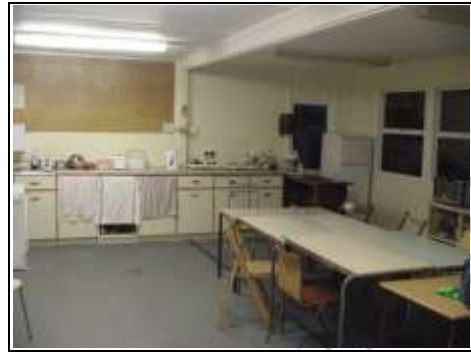
Makeshift Portakabin kitchen

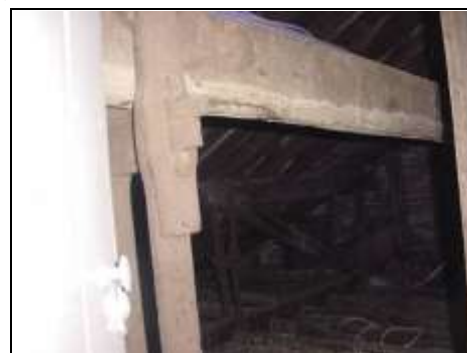
Conditions are present for woodworm with the dampness and the warming up of the environment and with the occupation of the XXX people. The roof is the main area that we fear there is woodworm in this instance as we can see what looks to be old woodworm attack within the roof access adjacent to Room 14.

There are no obvious visual signs of what we would term as active or structurally significant damage, however we are aware that this time of year woodworm activity is minimal. In many properties there is an element of woodworm that is not active. Our inspection is usually restricted by insulation covering some of the timbers and general stored items in the roof, as it is restricted throughout the property by general fixtures and fittings.

Woodworm to front left hand side roof

ACTION REQUIRED: If you wish to be 100 per cent certain we would recommend a specialist report but we would wait until the spring months when the woodworm is more active.
