JOB REF: XXXX

ROOF REPORT

Leicester
Leicestershire
LE3 XXX

We have been instructed by XXXX to prepare an independent report on the main roof of the church.

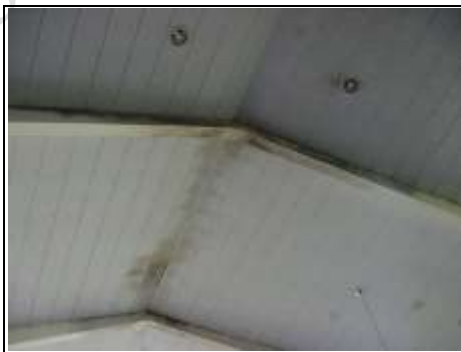
Close up of cold bridging

We believe that staining internally is partly due to cold bridging on the concrete portal frame.

Cold bridging is caused by a colder element in the structure allowing coldness to pass through the structure much quicker when warm moist air is present in the property.

We would recommend to reduce cold bridging increased background heating is added, you did at one time have high level heaters, we are advised that these are no longer in use.

We would also recommend re-instating the high level heating with a modern equivalent that should both help warm the property and reduce the cold bridging.

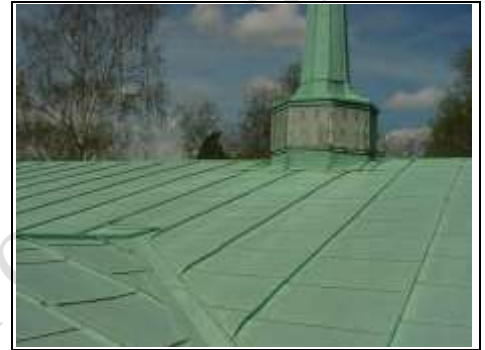
Main copper roof

1.0) Maintain the roof rather than replace the roof with professional repairs. We believe there is life still remaining in the main roof.

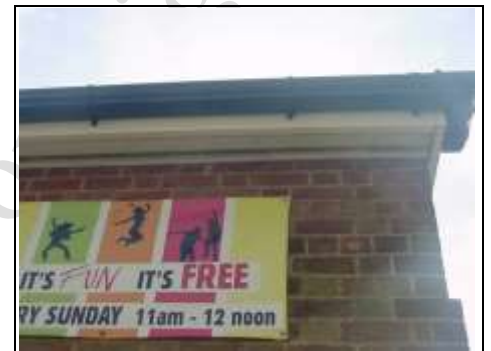
Vented soffit

We recommend improving ventilation in the main hall by adding vents to the soffit boards. As we understand it the original timber fascias and soffits have been overclad with plastic.

When adding vents check the condition of the fascias and soffits as you may need to replace the fascias and soffits completely if the timber is rotten below.

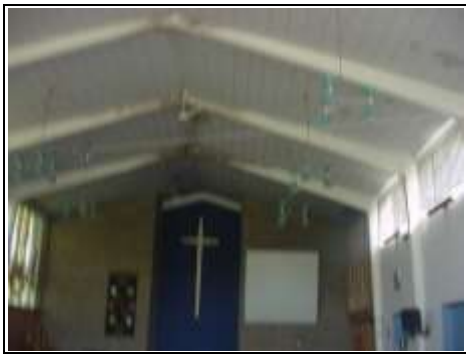
Concrete portal frame visible

- 7.1) Staining to the concrete portal frame known as cold bridging
- 7.2) Patch/spot staining which we believe is from the roof.

We recommend that the interior of the church is redecorated and the ceiling is monitored for any further patch/spot staining to monitor for leakage from weak areas of the roof.

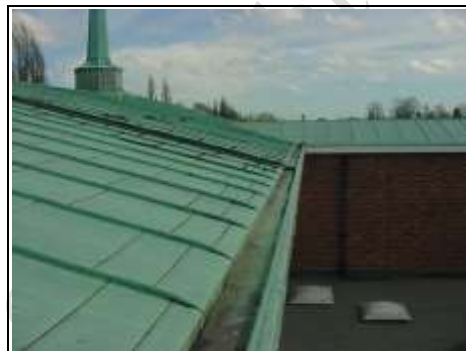
From what we could see the main copper roof is generally in average to slightly below condition for its age, type and style.

View of copper finished main roof

The main copper roof looks in reasonable condition, if anything we believe it has been damaged over the years by excessive access to carry out repairs that have been hit and miss.

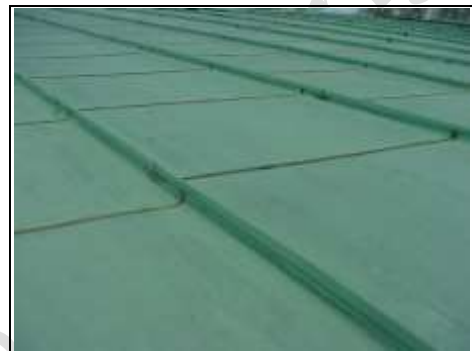
Double locking standing seam run vertically.

Vertical joints

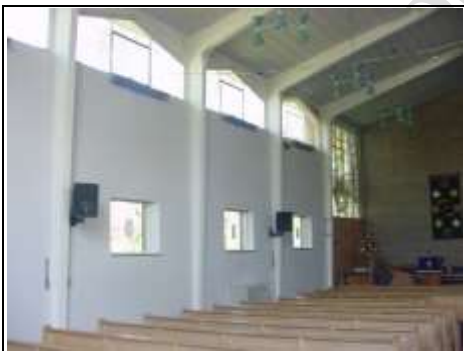
Portal frame left hand side

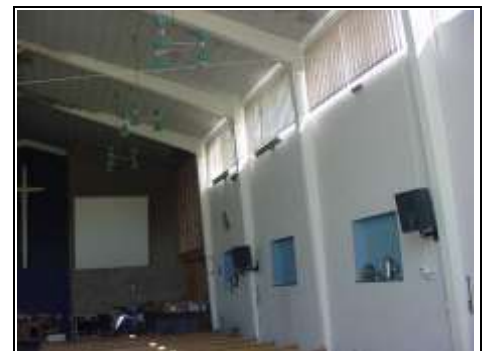
Portal frame right hand side

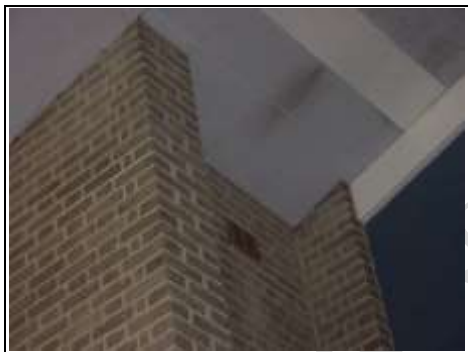
Front high level air vent

No doubt you would be surprised to find that a three by nine inch air vent, due to the way the air vents are produced, gives approximately one inch square of air circulation. We therefore believe that high level air ventilation needs to be increased.

ACTION REQUIRED: We would recommend additional vents are added at high level and in addition to this we would also recommend that the fascias and soffits have vents added too.

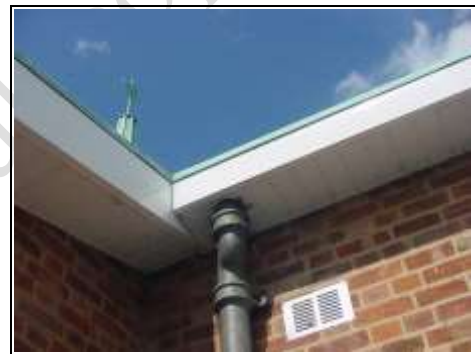
We believe that the fascias and soffits have been overclad which is not ideal vents need to be added as shown in our sketch.

Fascias and soffits, add ventilation into fascias however we would never recommend overcladding existing fascias and soffits and ideally this should be replaced rather than what we believe to be stick on fascias and soffits

ACTION REQUIRED: Vents need to be added to the overcladding which has occurred to the fascias and soffits. Please see our article on over cladding and cold bridging in the Appendices.

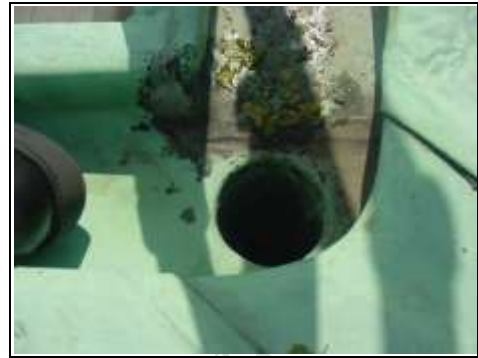
View from the main roof

Open up the downpipes to the full width to meet the internal gutters and have more regular clearing of gutters.

ANTICIPATED COST: In the region of £500 to £1000 (five hundred to one thousand pounds); please obtain quotations.

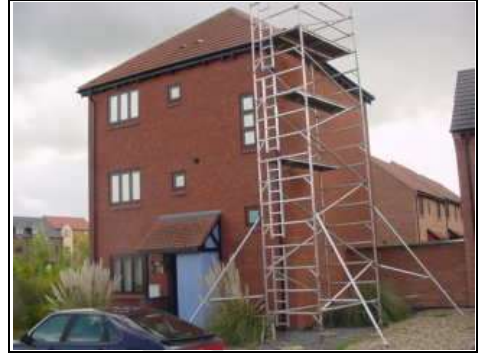
Tower scaffolding

- 8.3) Acquire your own scaffold tower to allow access at high level for maintenance contractors to carry out work and for you to check that the work has indeed been carried out. The term “fiddler on the roof” can be very true! Fixing ‘Eye’ bolts will also be required to secure high level tower scaffolding.

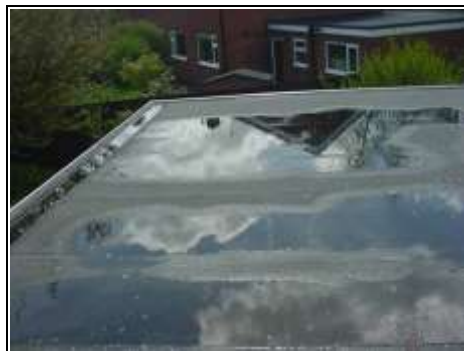
We feel that we should mention the flat roofs which are, in our opinion, too flat and are experiencing ponding. Flat roofs should be clear of all rainwater relatively shortly after rainfall and in this instance ponds of rainwater are sitting on the flat roofs. This ponding indicates to us that the falls were not correctly laid originally.

Excessive ponding front right hand side flat roof

We also note that the outlets from the flat roofs have been reduced by the way the felt has been inserted into the flat roofs.

ACTION REQUIRED: We recommend discussions with the original roof contractor as to the fall on the roof and we would also recommend that the outlets are opened up properly and given access to the downpipes as well as the downpipes having rodding eyes added.

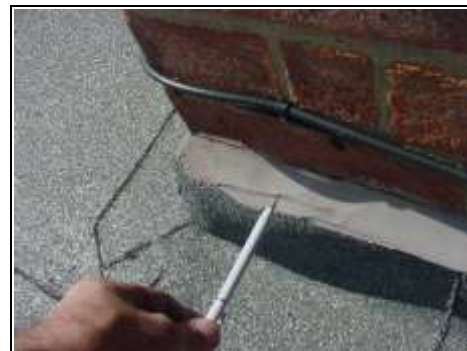
The perimeter of the flat roofs have a felt flashing and we would much prefer to see a lead flashing although we are aware there can be problems with precious metals being stolen.

Felt flashing

ACTION REQUIRED: Ideally we would recommend that all the felt flashings are replaced with lead flashings but we believe that as you have a relatively new felt flashing you should leave it in place until work is required in the next five to ten years.

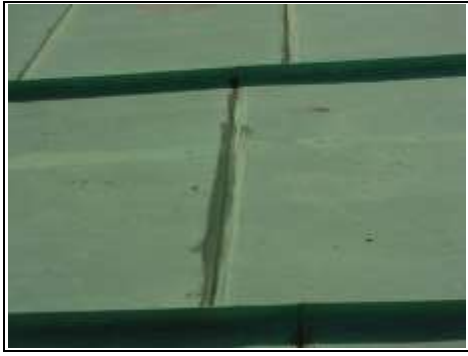
Close up of main copper roof

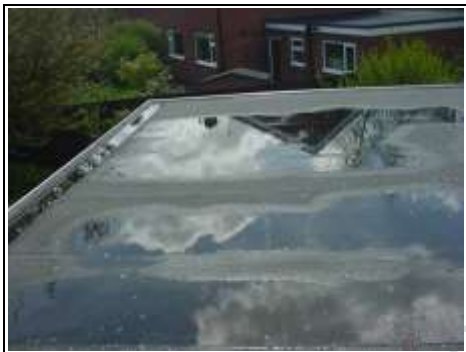
General view showing ponding

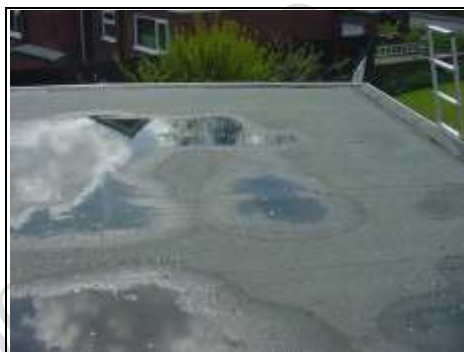
Ponding on flat roof

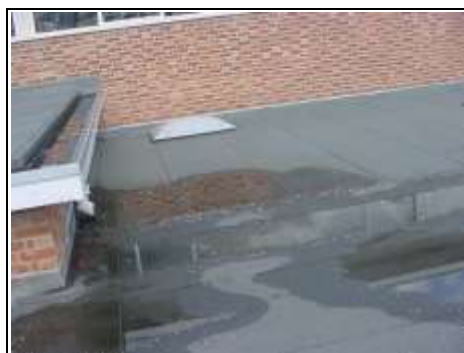
Smaller flat roof which is a slightly higher section

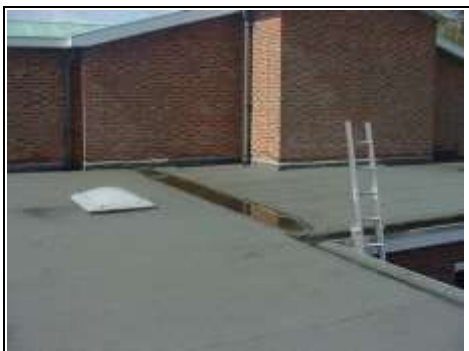
Rear flat roof general view

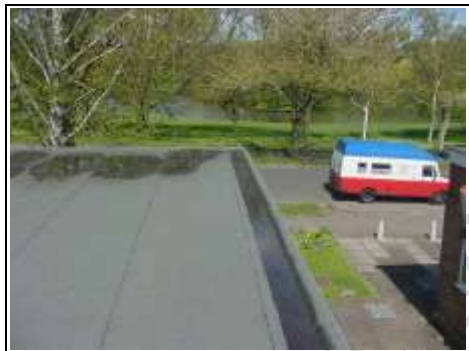
Rear flat roof showing internal gutters blocked and ponding

We would also recommend more regular clearing of gutters.

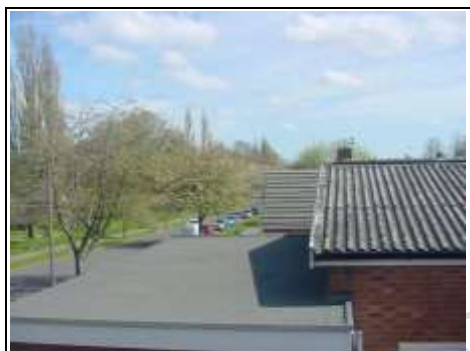
Partly flat roof partly corrugated asbestos roof

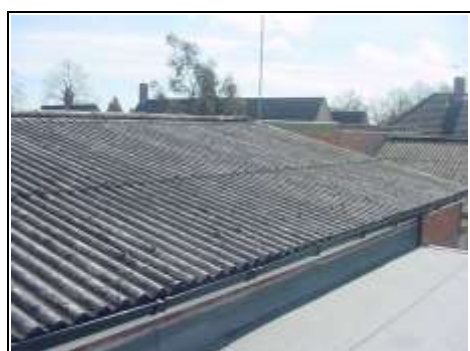
Asbestos roof. We believe that you have had an Asbestos Report carried out on the property as a whole

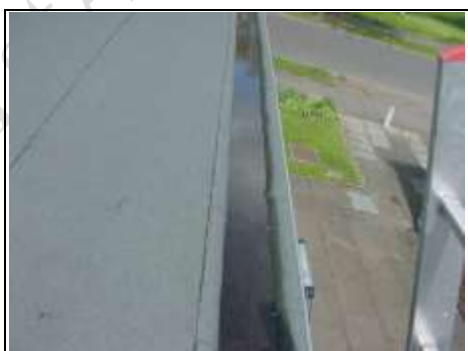
Rainwater sitting in internal gutter

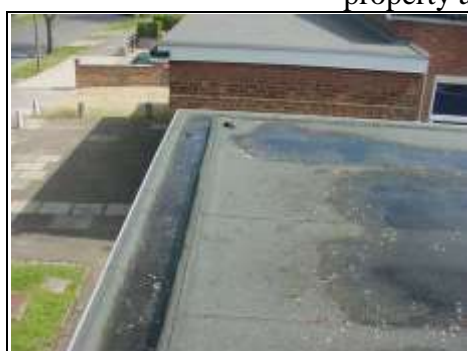
Blockage causing rainwater to sit in internal gutter

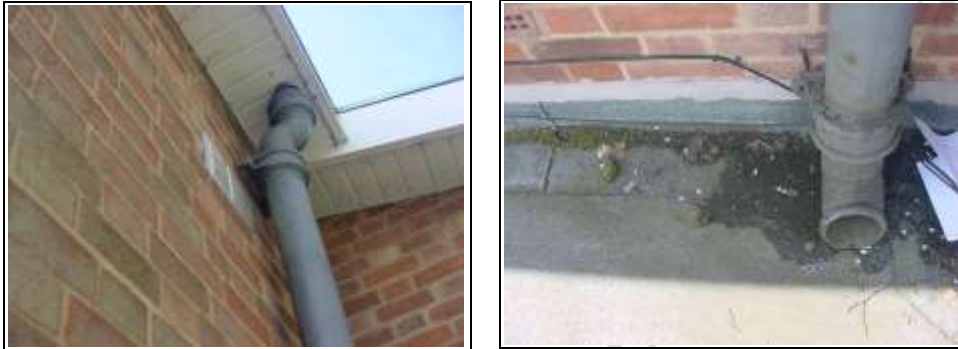
The main roof discharges rainwater onto the flat roofs via cast iron downpipes.

Cast iron downpipe

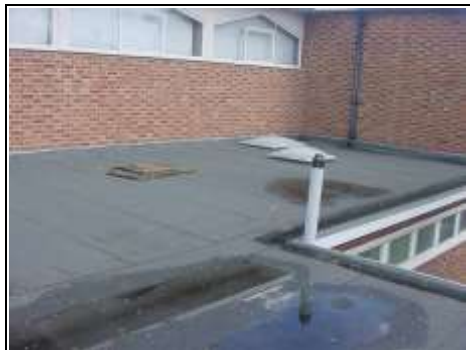
There are limited falls to these gulley's and the outlet has been restricted.

Rainwater sitting on the roof and in the gulley's

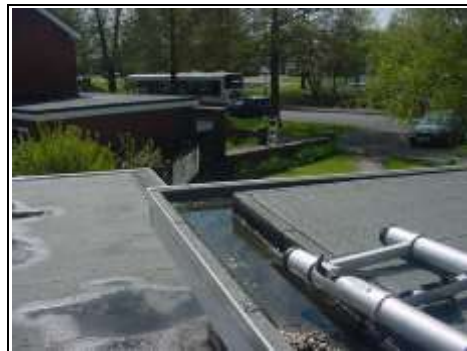
Outlet restricted

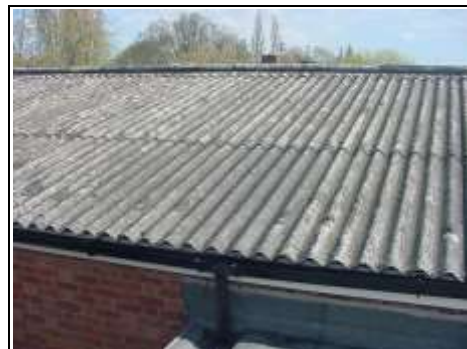
The rear corrugated asbestos type flat roof has a newish profile shaped plastic gutter.

Newish profile shaped plastic gutter
